CONDITION ASSESSMENT REPORT FOR

THE WILLOWS

A PROPERTY OWNED BY RADNOR TOWNSHIP, PENNSYLVANIA

Avison Young

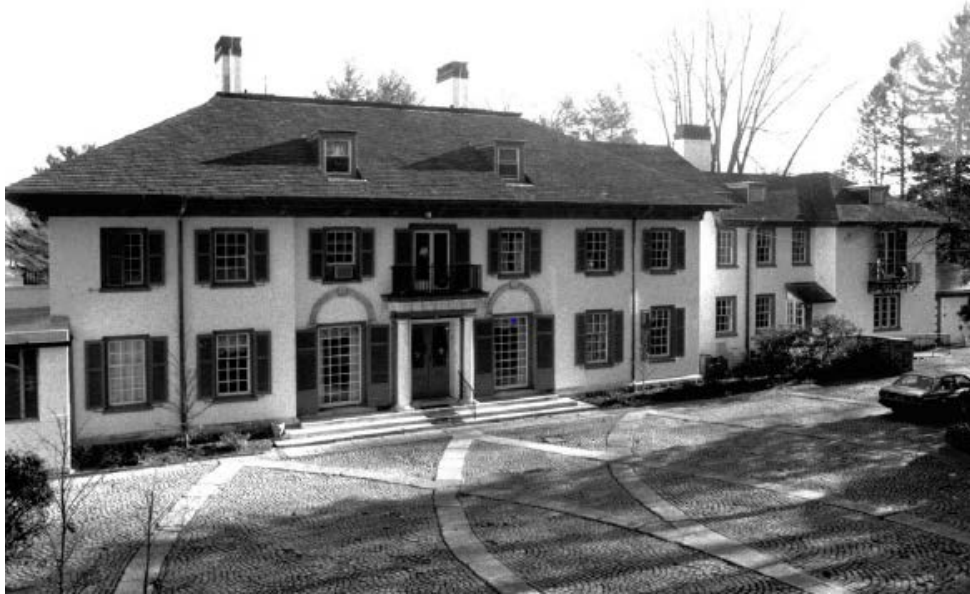
Figure 2 Archival image of the front facade. The French doors flanking the front door have already been replaced with fixed infill windows.

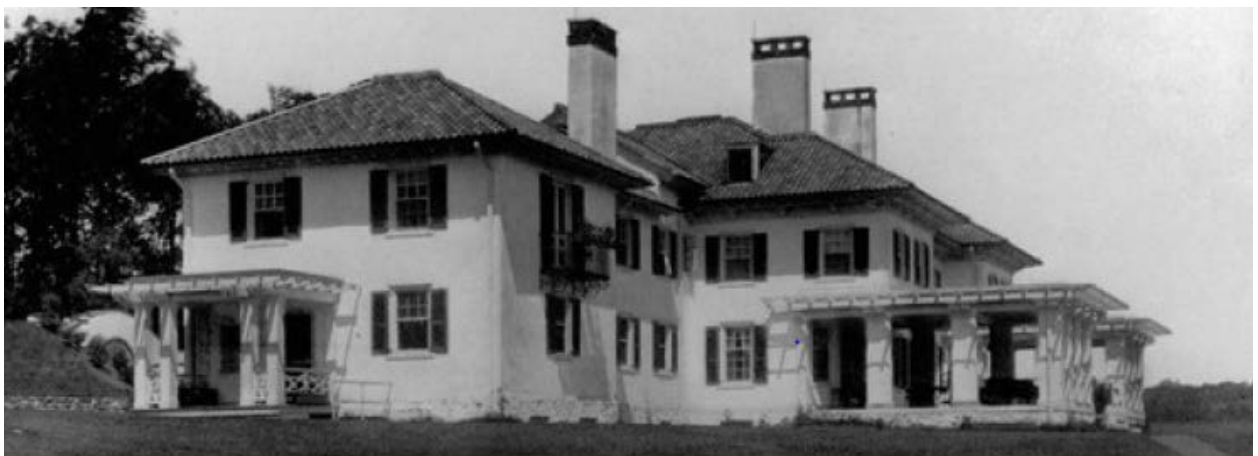
Figure 3 Archival image of the Right and Rear facades. Note that the storage garage is not constructed yet. The Dining and Living rooms still have their original back walls and the covered terraces are still intact. The roof tiles are Spanish tiles, not the current shingle style terra cotta tiles.

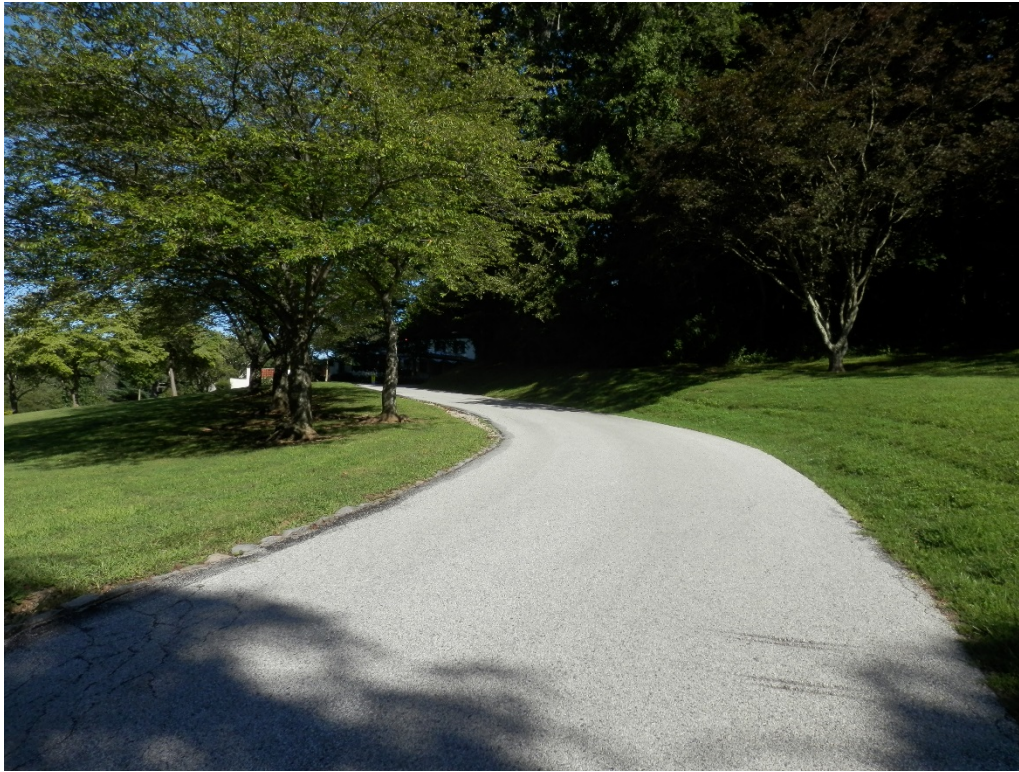
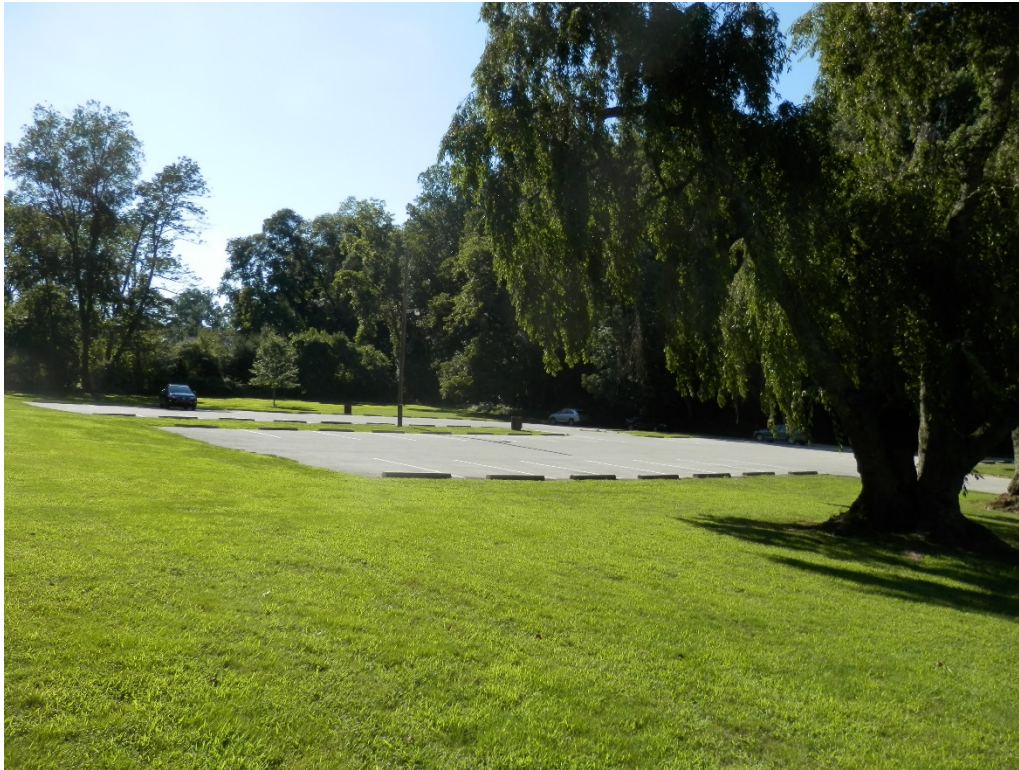
Paving, Curbing, Parking

The paved driveway leading to the house is in good condition. There are no curbs in this park setting. The courtyards are sloped toward drains. The paving has some cracking and some uneven areas due to tree roots heaving the pavement and freeze-thaw movement. The "well" feature in the secondary courtyard sits above the courtyard on a circular stone base raised by a series of steps. The pavers comprising the steps are mortared in-place and the mortar is cracked or missing in areas. Some of the steps are subsequently dislodged or uneven.

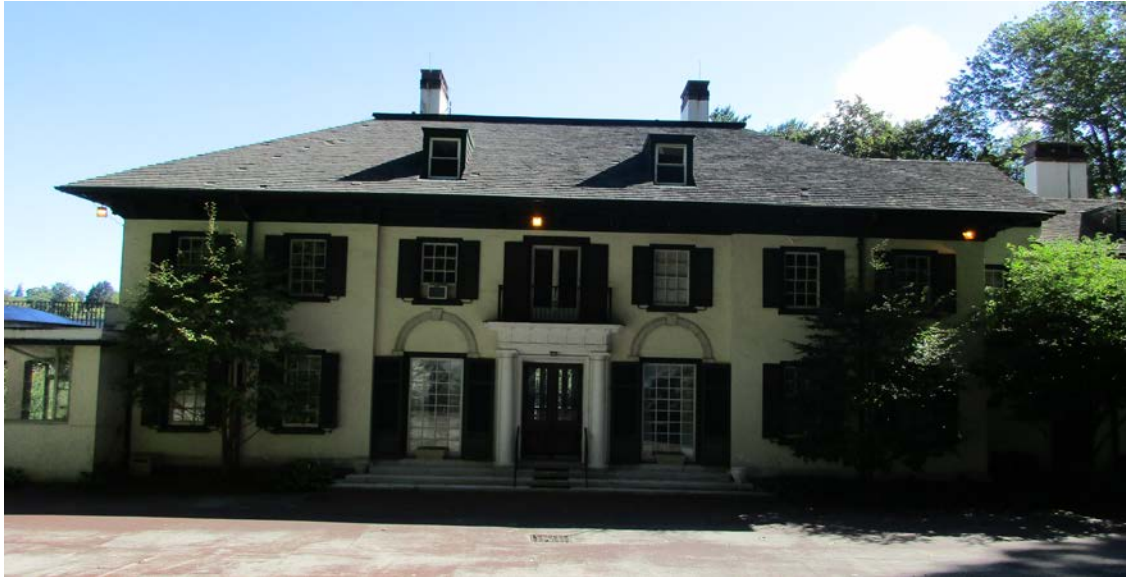
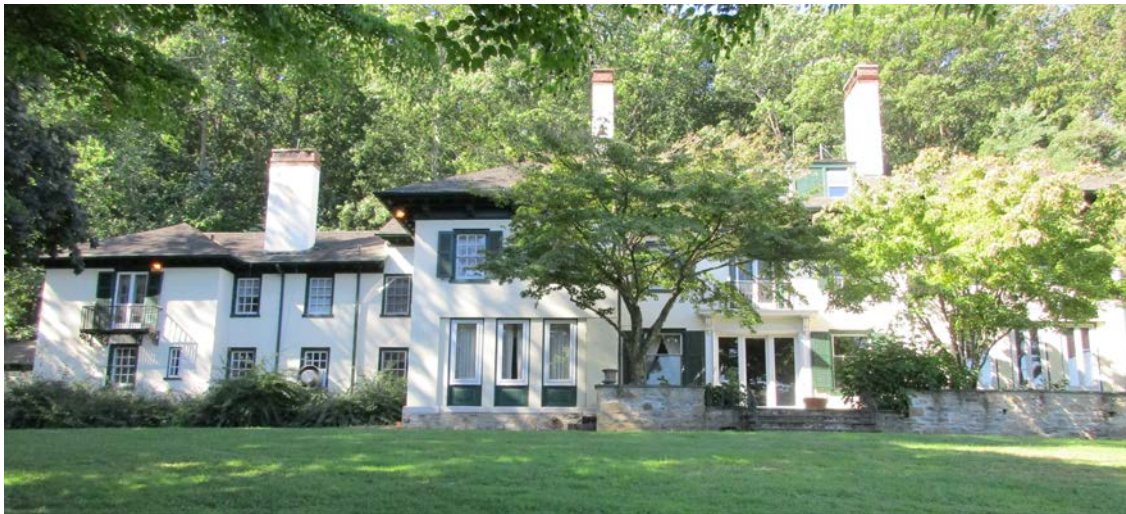
Building Structure & Facade

The house has a stone masonry foundation and stucco clad walls. The house is a masonry load bearing building. There is cracking and mortar missing in areas of the foundation and along the raised terrace areas. There is organic staining on portions of the stucco due to water and moss growth. Areas of stucco are also spalled and cracked.

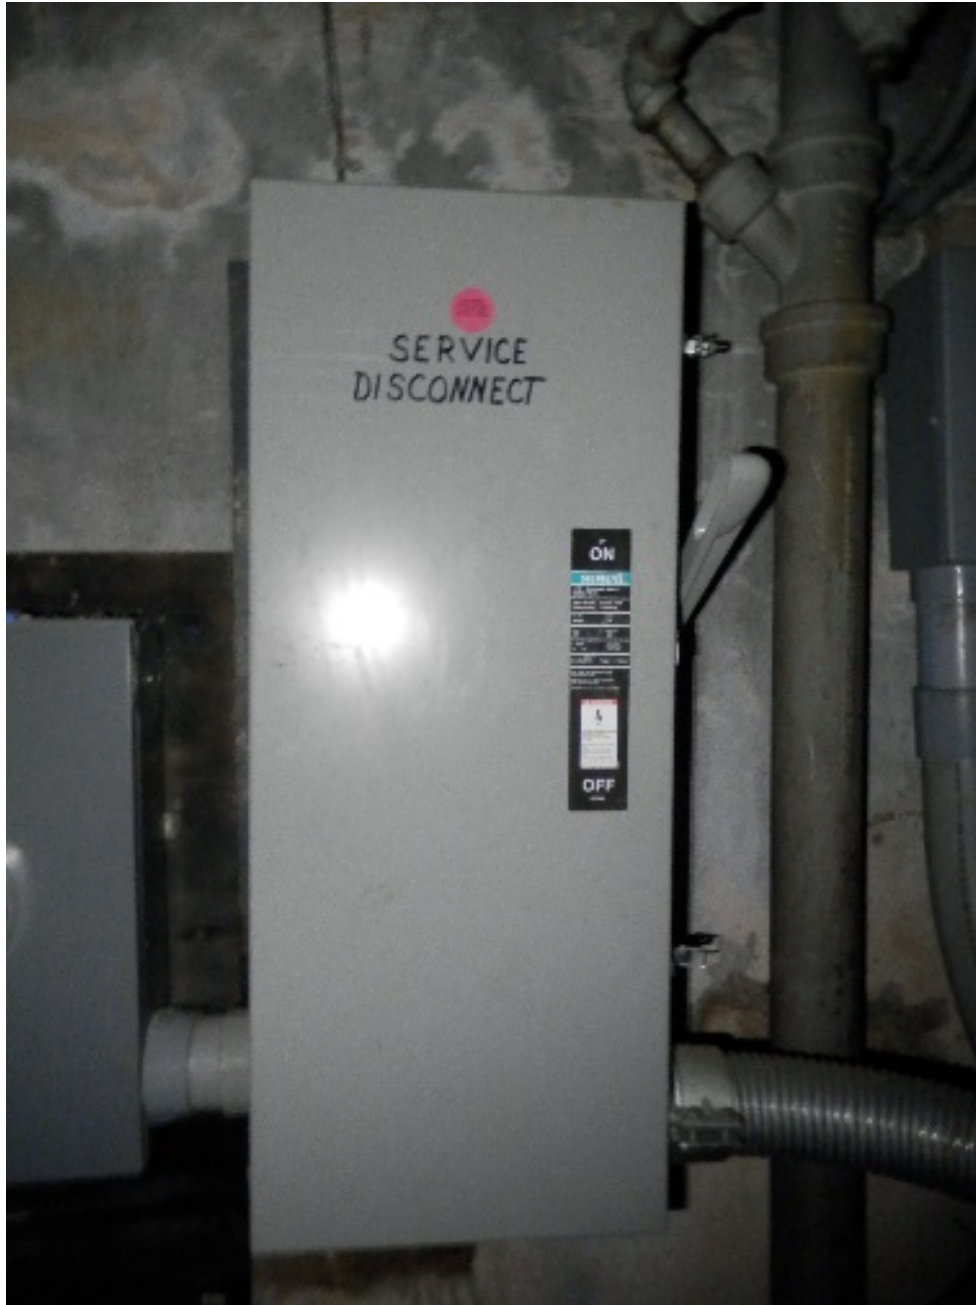
Electrical

There were 4 electrical panels, a trench emergency generator and transfer switch with a service disconnect panel observed. The Cummins power generation appears to be inspected regularly. Every Monday at approximately 10:30am, the generator is tested and runs for about 30 minutes. The major concerns are the antiquity of the wiring, the frequent power overloads, and the need to meet current codes.
