Radnor Township
Stormwater Management Advisory Committee (SWMAC)
Agenda
7:00pm, Thursday, March 10, 2016

In accordance with the scope of work and cost proposal to provide engineering services for the evaluation of five (5) bridges/culverts submitted to Radnor Township on July 1, 2015, Gannett Fleming completed the field view and prepared a summary report for each bridge. The reports summarize the findings from field view and recommend the appropriate option to replace or rehabilitate the deteriorated structures. A conceptual construction cost estimate and estimate of engineering cost for the recommended work is prepared for each structure for your budgeting purposes. Actual engineering costs will be developed based on the final scope of services for each task.

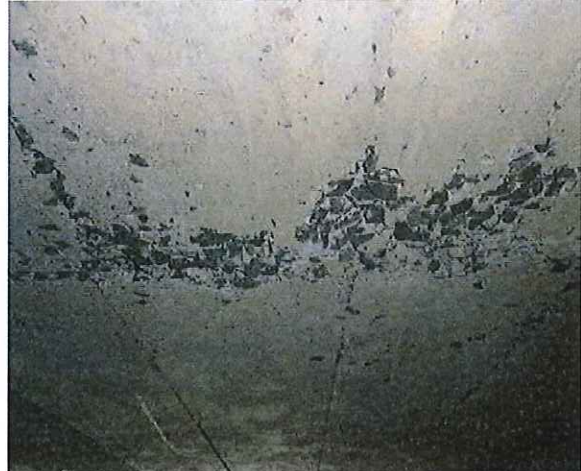
The concrete slab superstructure of the main structure is in good condition with localized honeycombing and exposed aggregate. No spalls or exposed reinforcing steel is noted.

Honeycombing and Exposed Aggregate

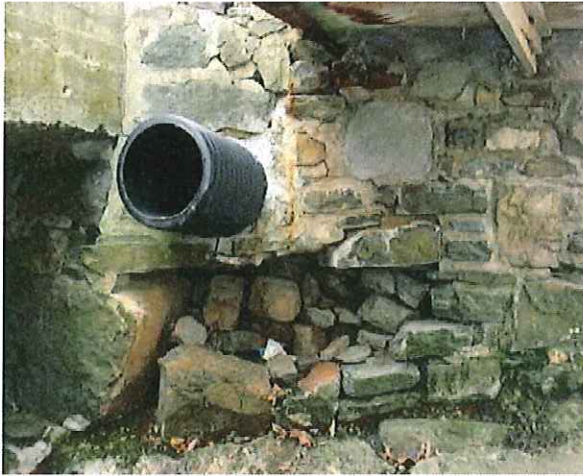
At Wing D, stones are missing from below the 12" diameter drainage pipe with more than 12" undermining; Wing A exhibits missing stone, missing mortar joints and water leakage at the groundline.

Missing Stones and Undermining in Wing D

The Superstructure of the north pedestrian bridge and Wing D are in poor condition. Wing A is in fair condition.

- Replace superstructure and substructure of north pedestrian bridge.
- Repoint missing mortar joints in abutments and wingwalls.
- Repair/Repaint the south pedestrian bridge, update railing to meet the current standards.
- Fill the scour hole at outlet and in front of concrete apron of wingwalls B & C with riprap.
- We will discuss with the township about the need for updating safety features of roadway bridge and pedestrian bridges.
- Install the missing hazard marker at northwest corner.

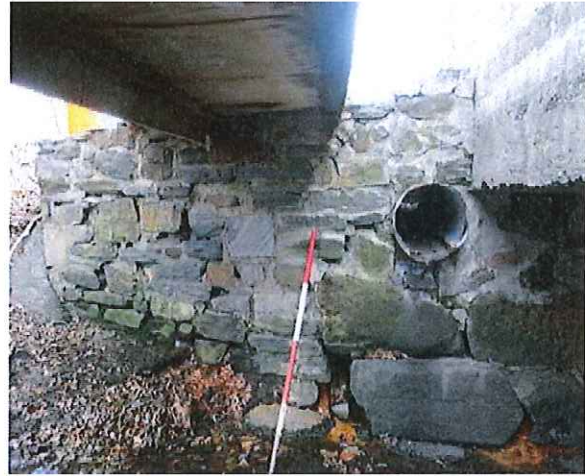
Missing Stones and Mortar Joints in Wing A

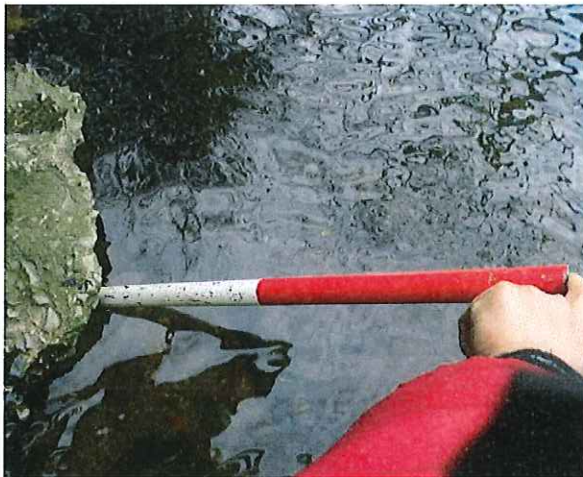
Note that concrete aprons of varying width are present at both Wing B and Wing C (downstream wings). It is assumed that the aprons serve the purpose of splash block for ground water flows into the creek through drainage pipes. Both aprons are undermined up to 2'-0". Streambed under the bridge is paved with concrete and in good condition; water flow over the streambed is approximately 1" deep. A waterfall is formed at end of the paved streambed and a 2'-3" deep scour hole beyond the paved streambed between Wing B and Wing C is noticeable. There is no noticeable bank erosion.

2' Undermining under Wing B Apron

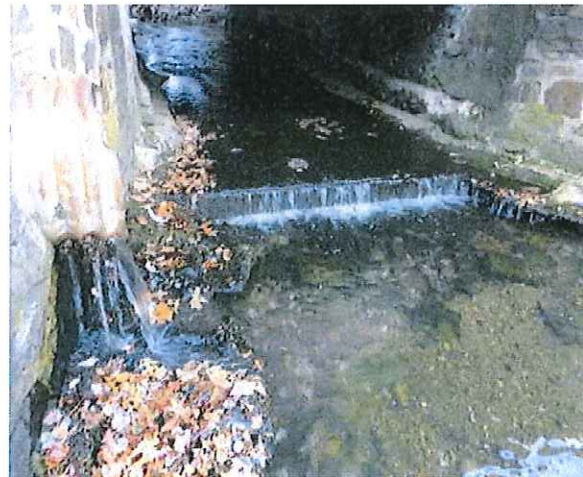
Large Scour Hole at end of Culvert

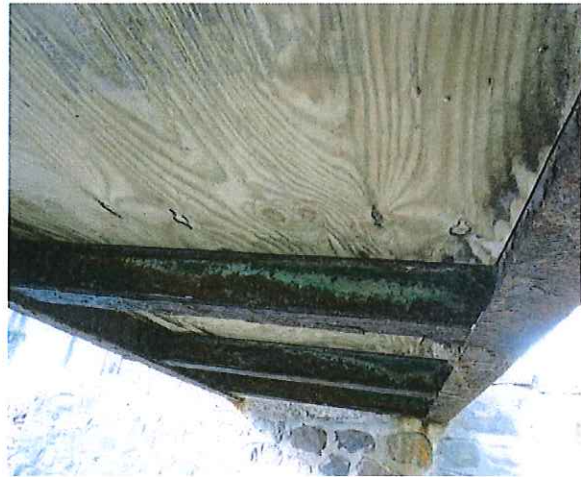
The south pedestrian bridge features two (2) W12 stringers with five (5) W5 floor beams and a pressure-treated plywood stay-in-place form. Both stringers and floor beams exhibit heavy rust and delamination with minor section loss throughout; the plywood form is in fair condition.

South Pedestrian Bridge Underdeck View

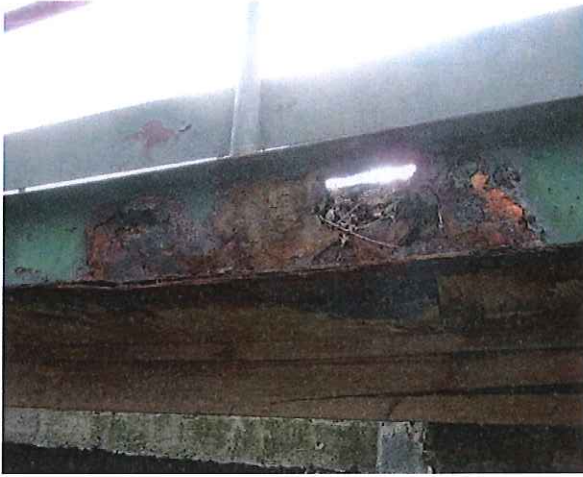
The north pedestrian bridge is composed of two (2) W8 stringers, concrete deck and plywood form, and is also supported by a built-up auxiliary timber T-beam (2x6 flange and stem). The W8 stringers are heavily rusted with 100% loss of webs and more than 50% loss of bottom flanges and are losing their carrying capacities. A Large hole is noticeable in the concrete deck and plywood form. The stem of the built-up timber T-beam splits at middle depth from the end notch.

100% Loss in Web of North Stringer

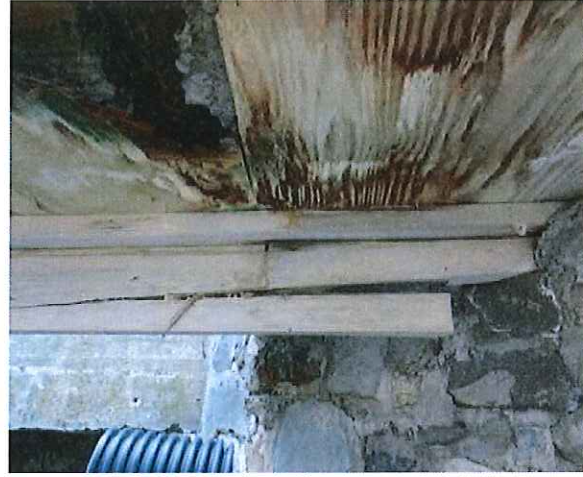
Large Hole in Deck and Horizontal Split in Stem of T-Beam

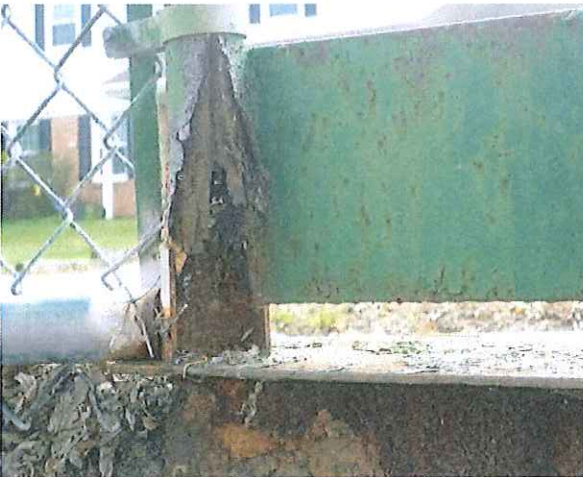
Railing posts for the north pedestrian bridge are either broken or rusted with total section loss. Railing and posts for the south pedestrian bridge are in fair condition.

Section Loss in N. Railing Post of North Pedestrian Bridge

Two of five railing posts of the north pedestrian bridge are ineffective due to either excessive damage or 100% section loss at the base. The rest of the railing posts are in fair condition with heavy rust at the base.

The pedestrian bridges railings are a hazard and should be replaced with the PennDOT Standard Aluminum Pedestrian Railing in BC-716M or approved equivalent.

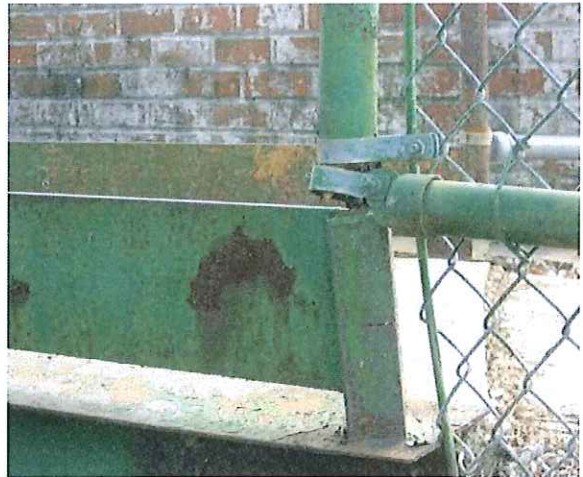
Broken Railing Post in N. Railing of North Pedestrian Bridge

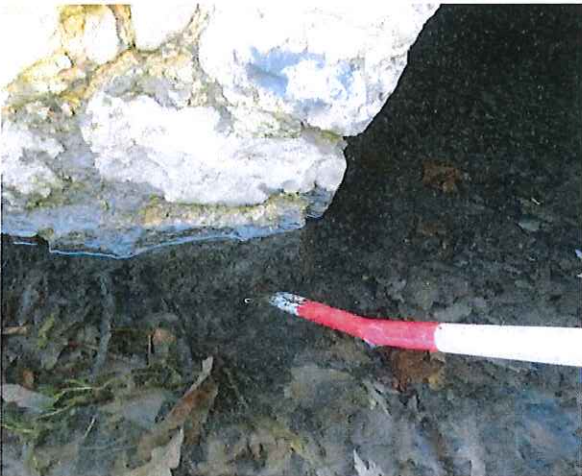
1'-0" Undermining at Outlet

The concrete portions of twin arch barrels are in fair condition. There is undermining up to 1'-0", along north barrel with a total length of 10'. Heavy scaling is noted along the water surface line and there is heavy debris accumulation in both barrels. There is a large scour hole at inlet of the culvert.

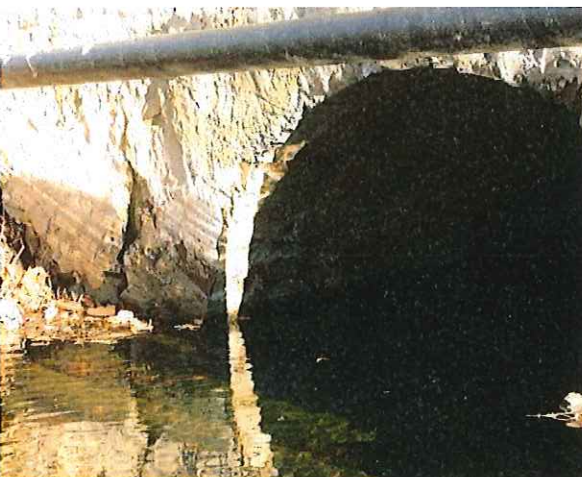
Spall and Missing Stones in Upstream Masonry Headwall of North Barrel

The masonry headwalls are in poor condition. The upstream headwall has large areas of missing stones and mortar.

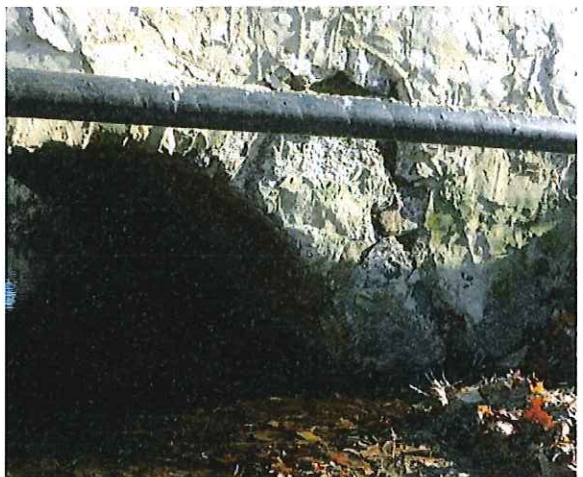
Spall and Missing Stones in Upstream Masonry Headwall of South Barrel

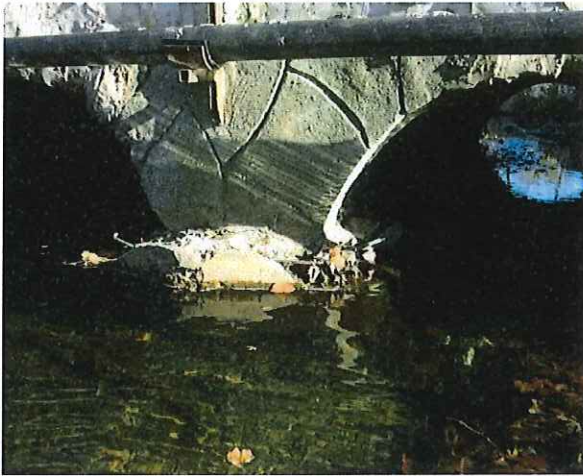
Undermining and Spall in Upstream Pier Footing

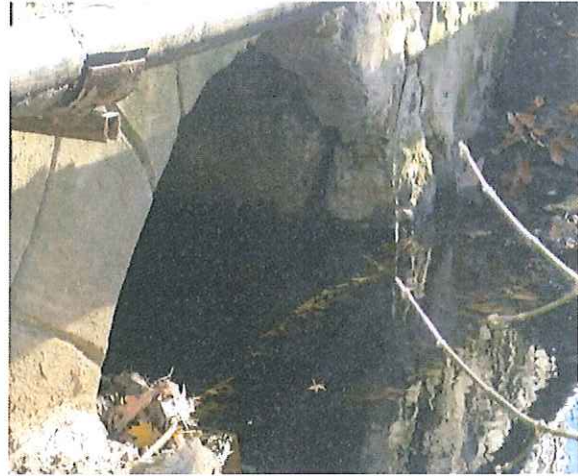
Failing Upstream Headwall in South Barrel

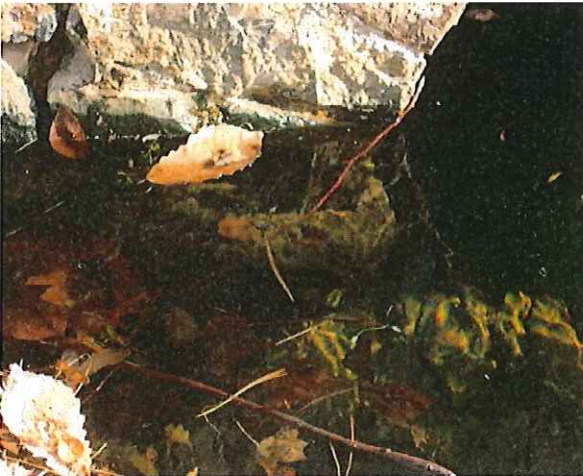
The concrete arch barrels are in fair condition with minor honeycombing occasionally. Scour and undermining are noticed along the north barrel footings about 10' total length. In addition, there is a large scour hole about 2'-6" deep at the inlet of culvert. Heavy debris accumulation is present in both barrels. Findings on the culvert and the retaining wall are summarized as follows:

Scour and Exposed Footing at Upstream North Barrel

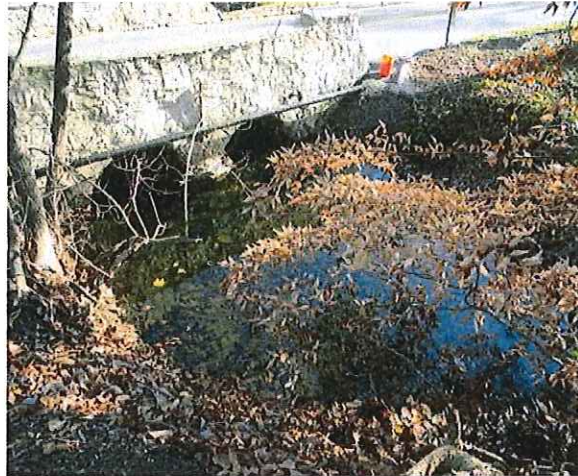
Large Scour Hole/Pond formed at Culvert Inlet

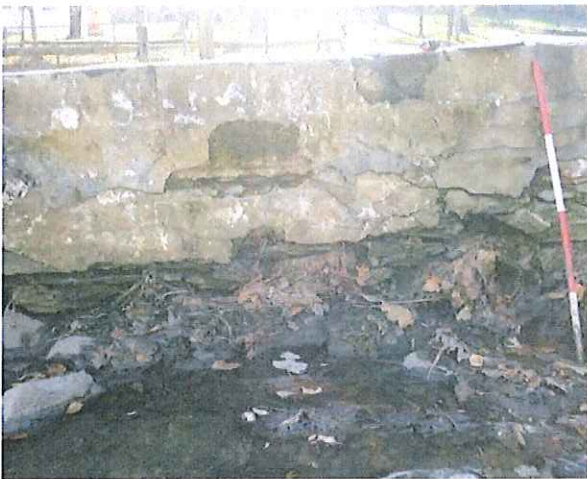
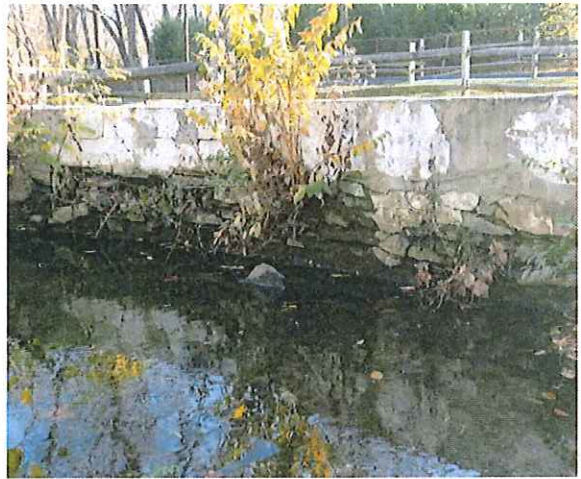
There is a stone masonry retaining wall that defines the edge of channel on the downstream south quadrant. The top width of retaining wall is 1'-0" wide and the height of retaining wall measured from streambed is approximately 4'-6" tall. The bottom 2'-6" of the wall has advanced deterioration with large area of undermining and missing stone and jointing along the length.

The masonry retaining wall along the downstream embankment is in serious condition with large areas of undermining and missing stone and jointing along the length.

Based on the field assessment and finding, it is recommended to rehabilitate the existing culvert and replace the entire downstream retaining wall. The major works are listed below:

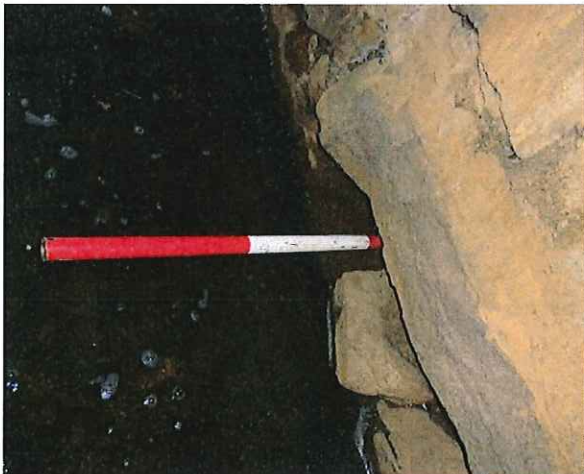
2' Deep Void in North Abutment

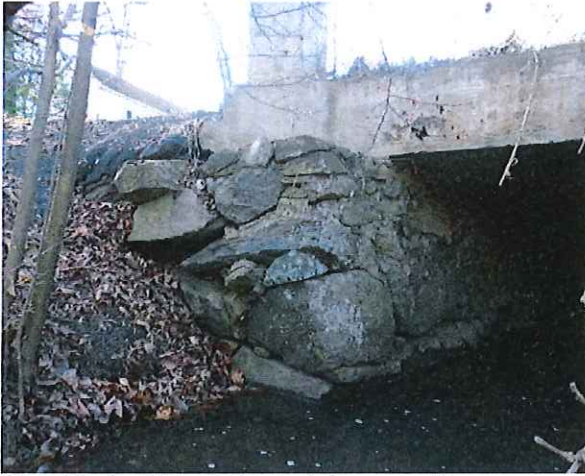
*East End of South Stone Masonry Abutment,
Note Large Stones with Missing Mortar Joints*

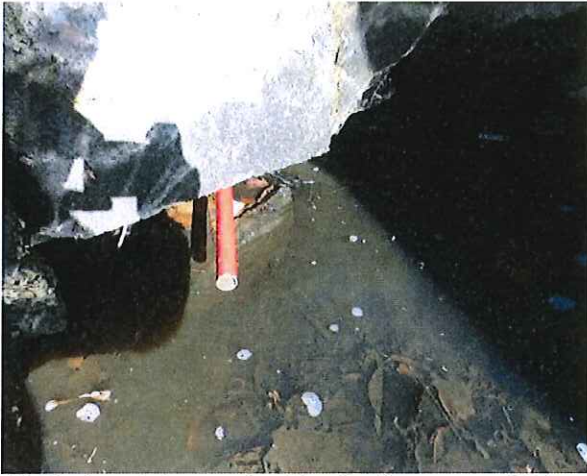
The widened inlet structure is in poor condition; both abutments are severely undermined.

4' Undermining under North Abutment of Inlet Structure

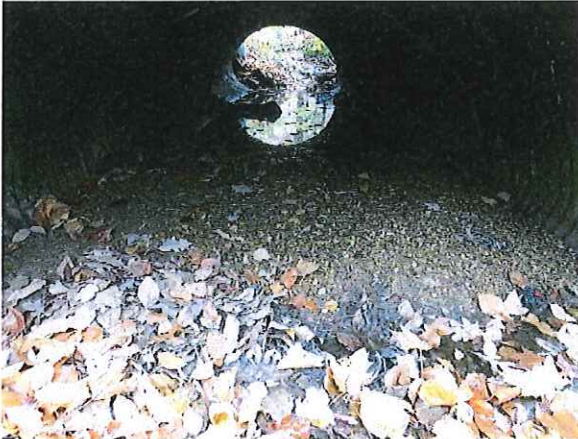
Both steel pipes are heavily corroded with rust laminations throughout. Water flow is diverted to the east pipe only. There is significant silt deposits throughout the west pipe and at the inlet. Water depth in the east pipe at the time of field investigation was approximately 6 inches.

West Pipe with Heavy Silt Built-up

- Replace the deteriorated corrugated pipe with a single cell precast box culvert.
- Install structure mounted guide rail.

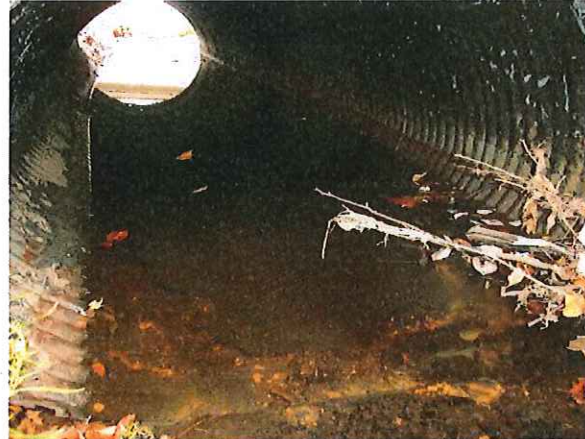
East Pipe with Apparent Heavy Rust

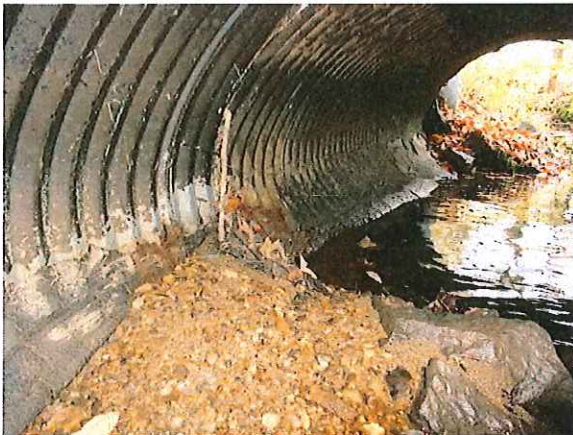
The dual corrugated metal pipes appear to be misaligned at the un-spliced abutting joints and have areas of distortion due to differential movement. The misalignment of the joint in the west pipe has resulted in the loss of fill behind the pipe wall. The crown of the east pipe for a distance of approximately 12 feet from the inlet appears to have excessive deformation. The location of the misalignment and deformation falls within the roadway travel lane.

Misaligned/Distorted West Pipe Shows Loss of Fill Material

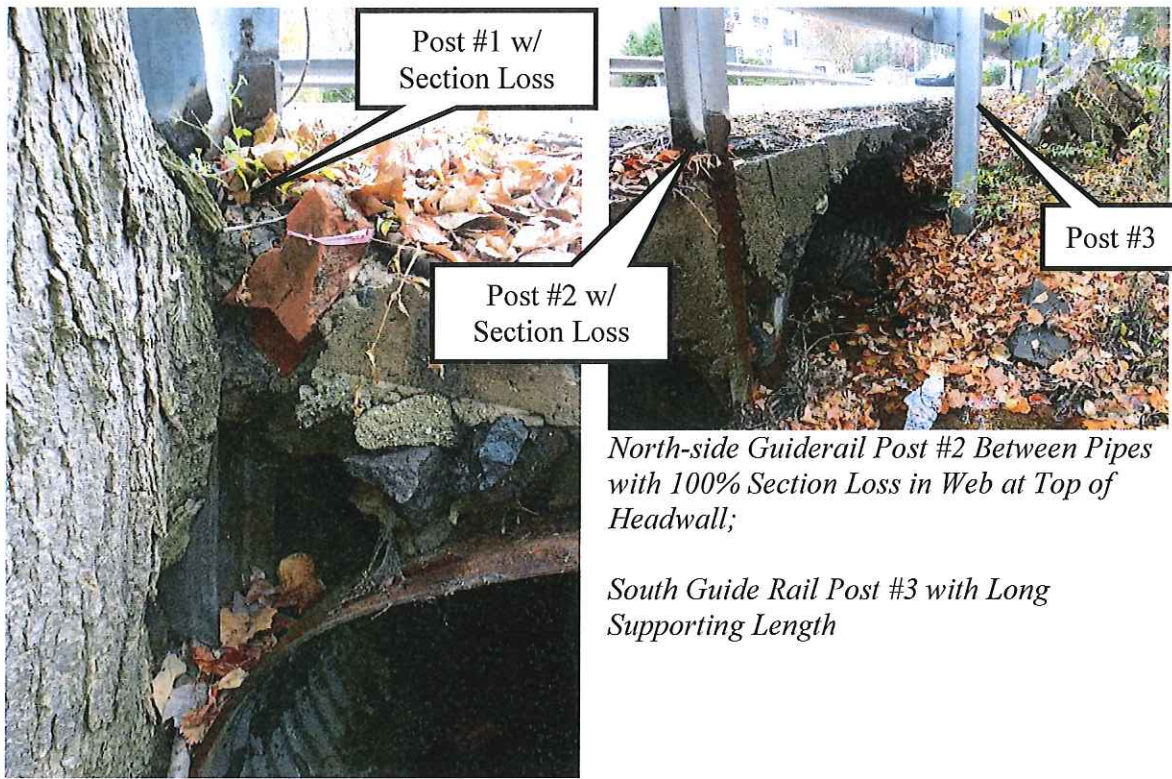
North-side Guiderail Post #1 Behind Tree

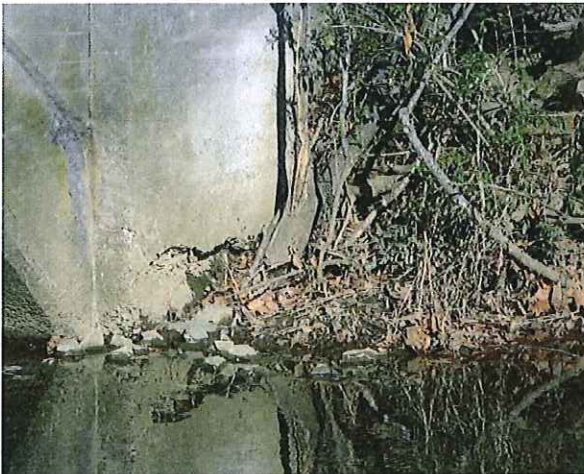
Large Spall at Bottom of Southeast Wingwall

- Repair spalls/cracks in fascia of arch ring
- Remove trees and provide riprap protection at downstream left bank to prevent further bank erosion.
- Relocate the pedestrian crosswalk to the west, away from the structure, to the intersection with Earles Lane. The trails within the parks could be reconfigured with minimal earth disturbance to affect this change. This will allow vehicles to better observe pedestrians in the crosswalk and will allow pedestrians to see oncoming traffic from the bridge.
- Provide painted yield bars on the roadway at both bridge approaches with adjacent signing "YIELD TO ONCOMING TRAFFIC". This will allow vehicles on either approach to yield to a vehicle already on the structure.
- Provide guide rail or crash worthy end treatments on all four corners of the structure.

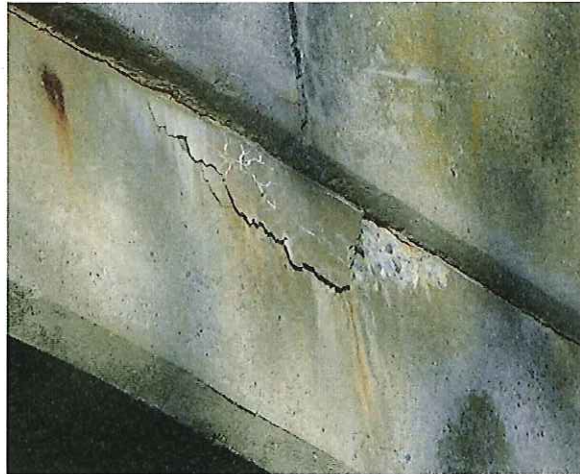
Surface Spall in South Fascia of Arch Barrel

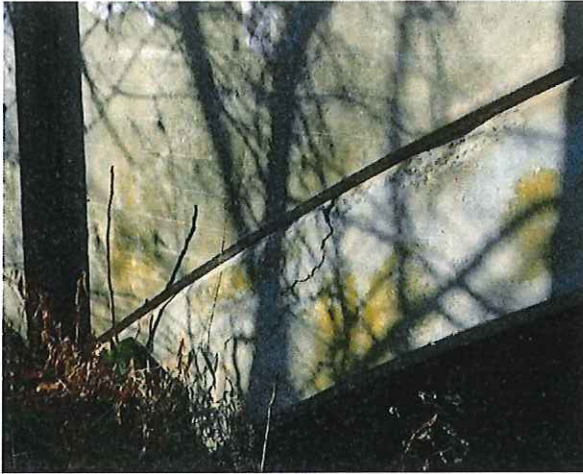
Surface Spall in South Fascia of Arch Barrel

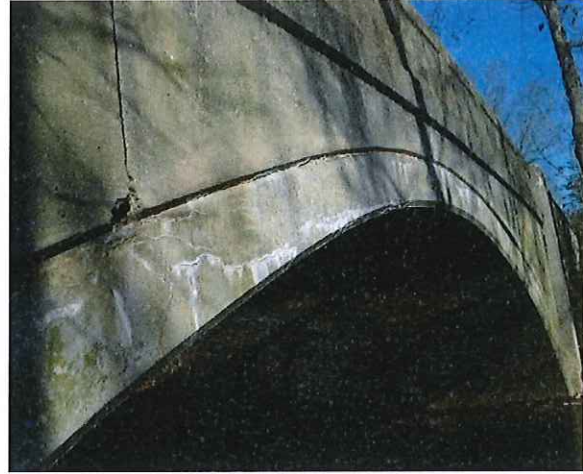
Small Spall in South Spandrel Wall and Fine Map Cracks with Efflorescence in South Fascia of Arch Barrel

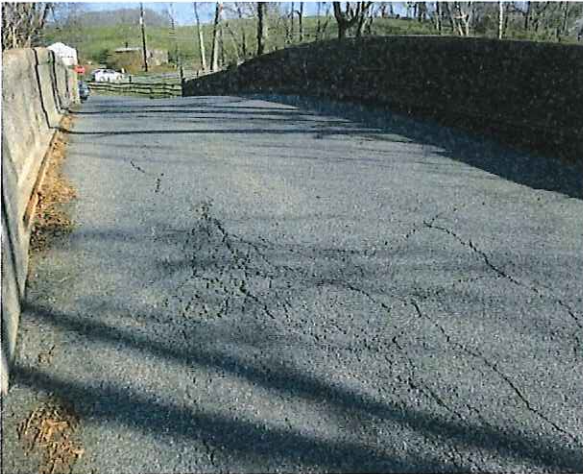
View of Pavement – Cracks throughout

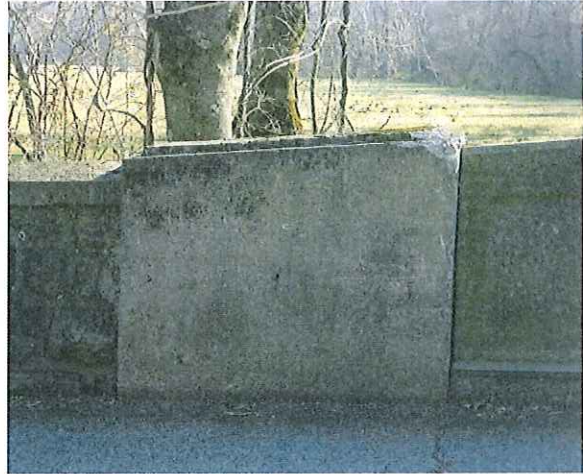
Spalls in Bridge Barrier

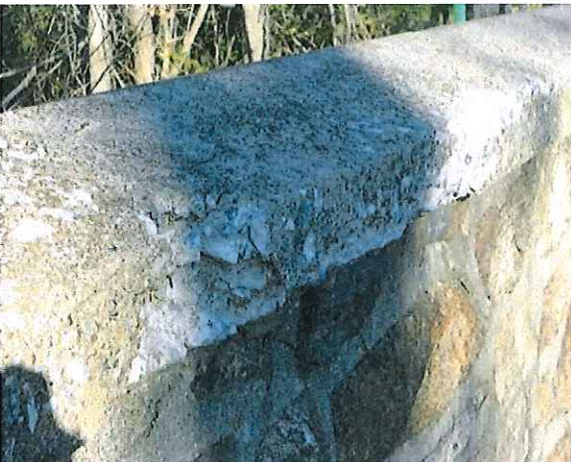
Spalls in Concrete Cap of Wingwall Barrier

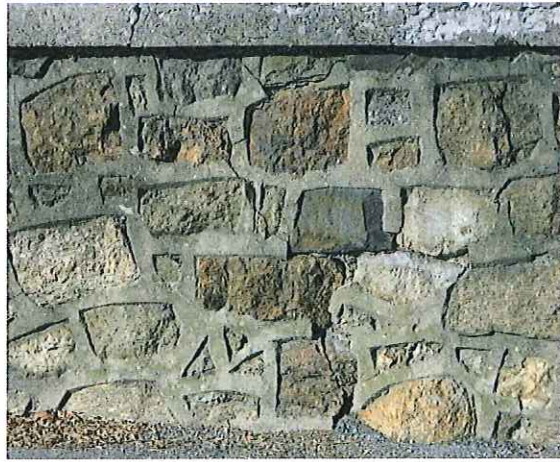
Cracks in Wingwall Barrier

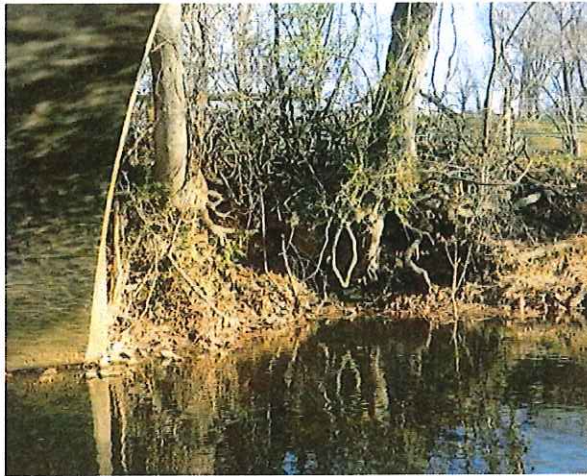
Bank Erosion with Exposed Tree Roots in Bank of Southeast Corner of the Bridge

There is a large sediment deposit under the arch blocking half the waterway channel. Water flows along the east abutment and causes severe bank erosion.
