Field Memorandum

Site: VU - Buffer / Parking lot

Reference: Vehicular light penetration to adjacent properties.

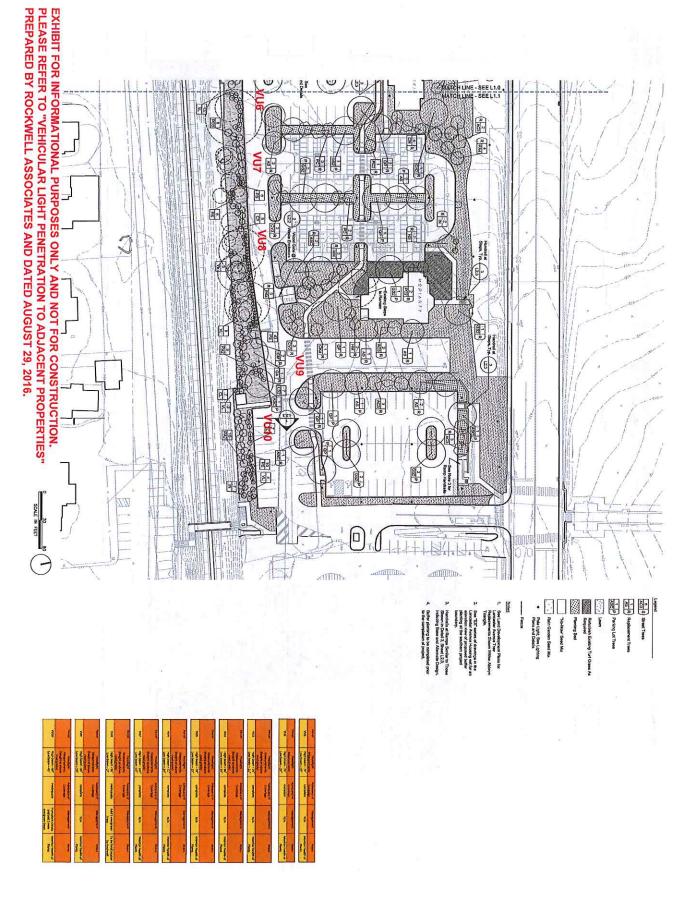
L1.1

It was evident that most of the planting buffer is satisfactory at its immature state. However, adjustments are required at parcels 8 and 10 which are located at the east end of this buffer near the new entrance route. These will require additional trees.
