Shade Tree Commission of
Radnor Township
Wayne, Pennsylvania

AGENDA

Wednesday
August 27, 2014
6:30 PM

***Hazardous Tree Removals
Approved for removal by Township Arborist***

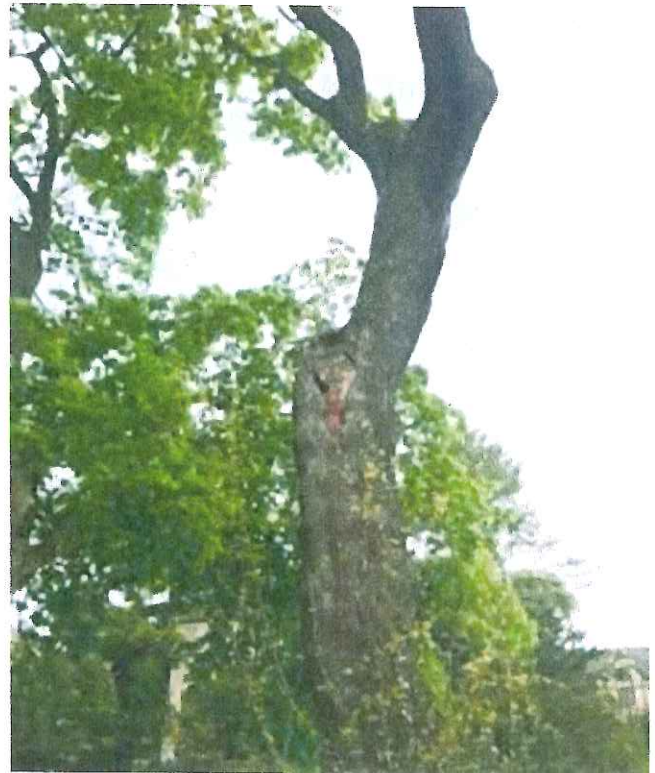
I did inspect the condition from your property of one 32" diameter Norway maple which has a large obvious trunk defect at approximately 35'. The defect in the tree is large and is easily seen from the ground. It is my opinion that it has considerable decay in the main area of the trunk and it has compromised the tree structurally in this area. I would recommend that this tree be removed. This is a very weak point in the tree and the whole top could fail if the conditions are right. I would recommend it for immediate removal.

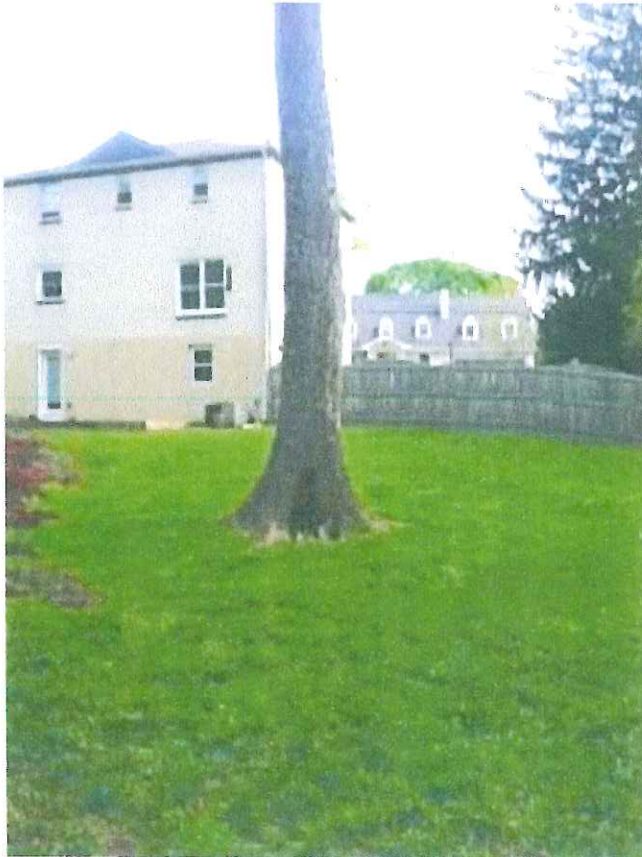
The 2nd tree is a 26" diameter Norway maple. We did inspect the condition of this tree from your property, looking through the fence; note the picture. There is a large decayed area in the base of the tree. This decay area has compromised the trunk of the tree. This tree should be removed before it falls onto your property, or one of the neighboring properties. I would recommend this tree for immediate removal.

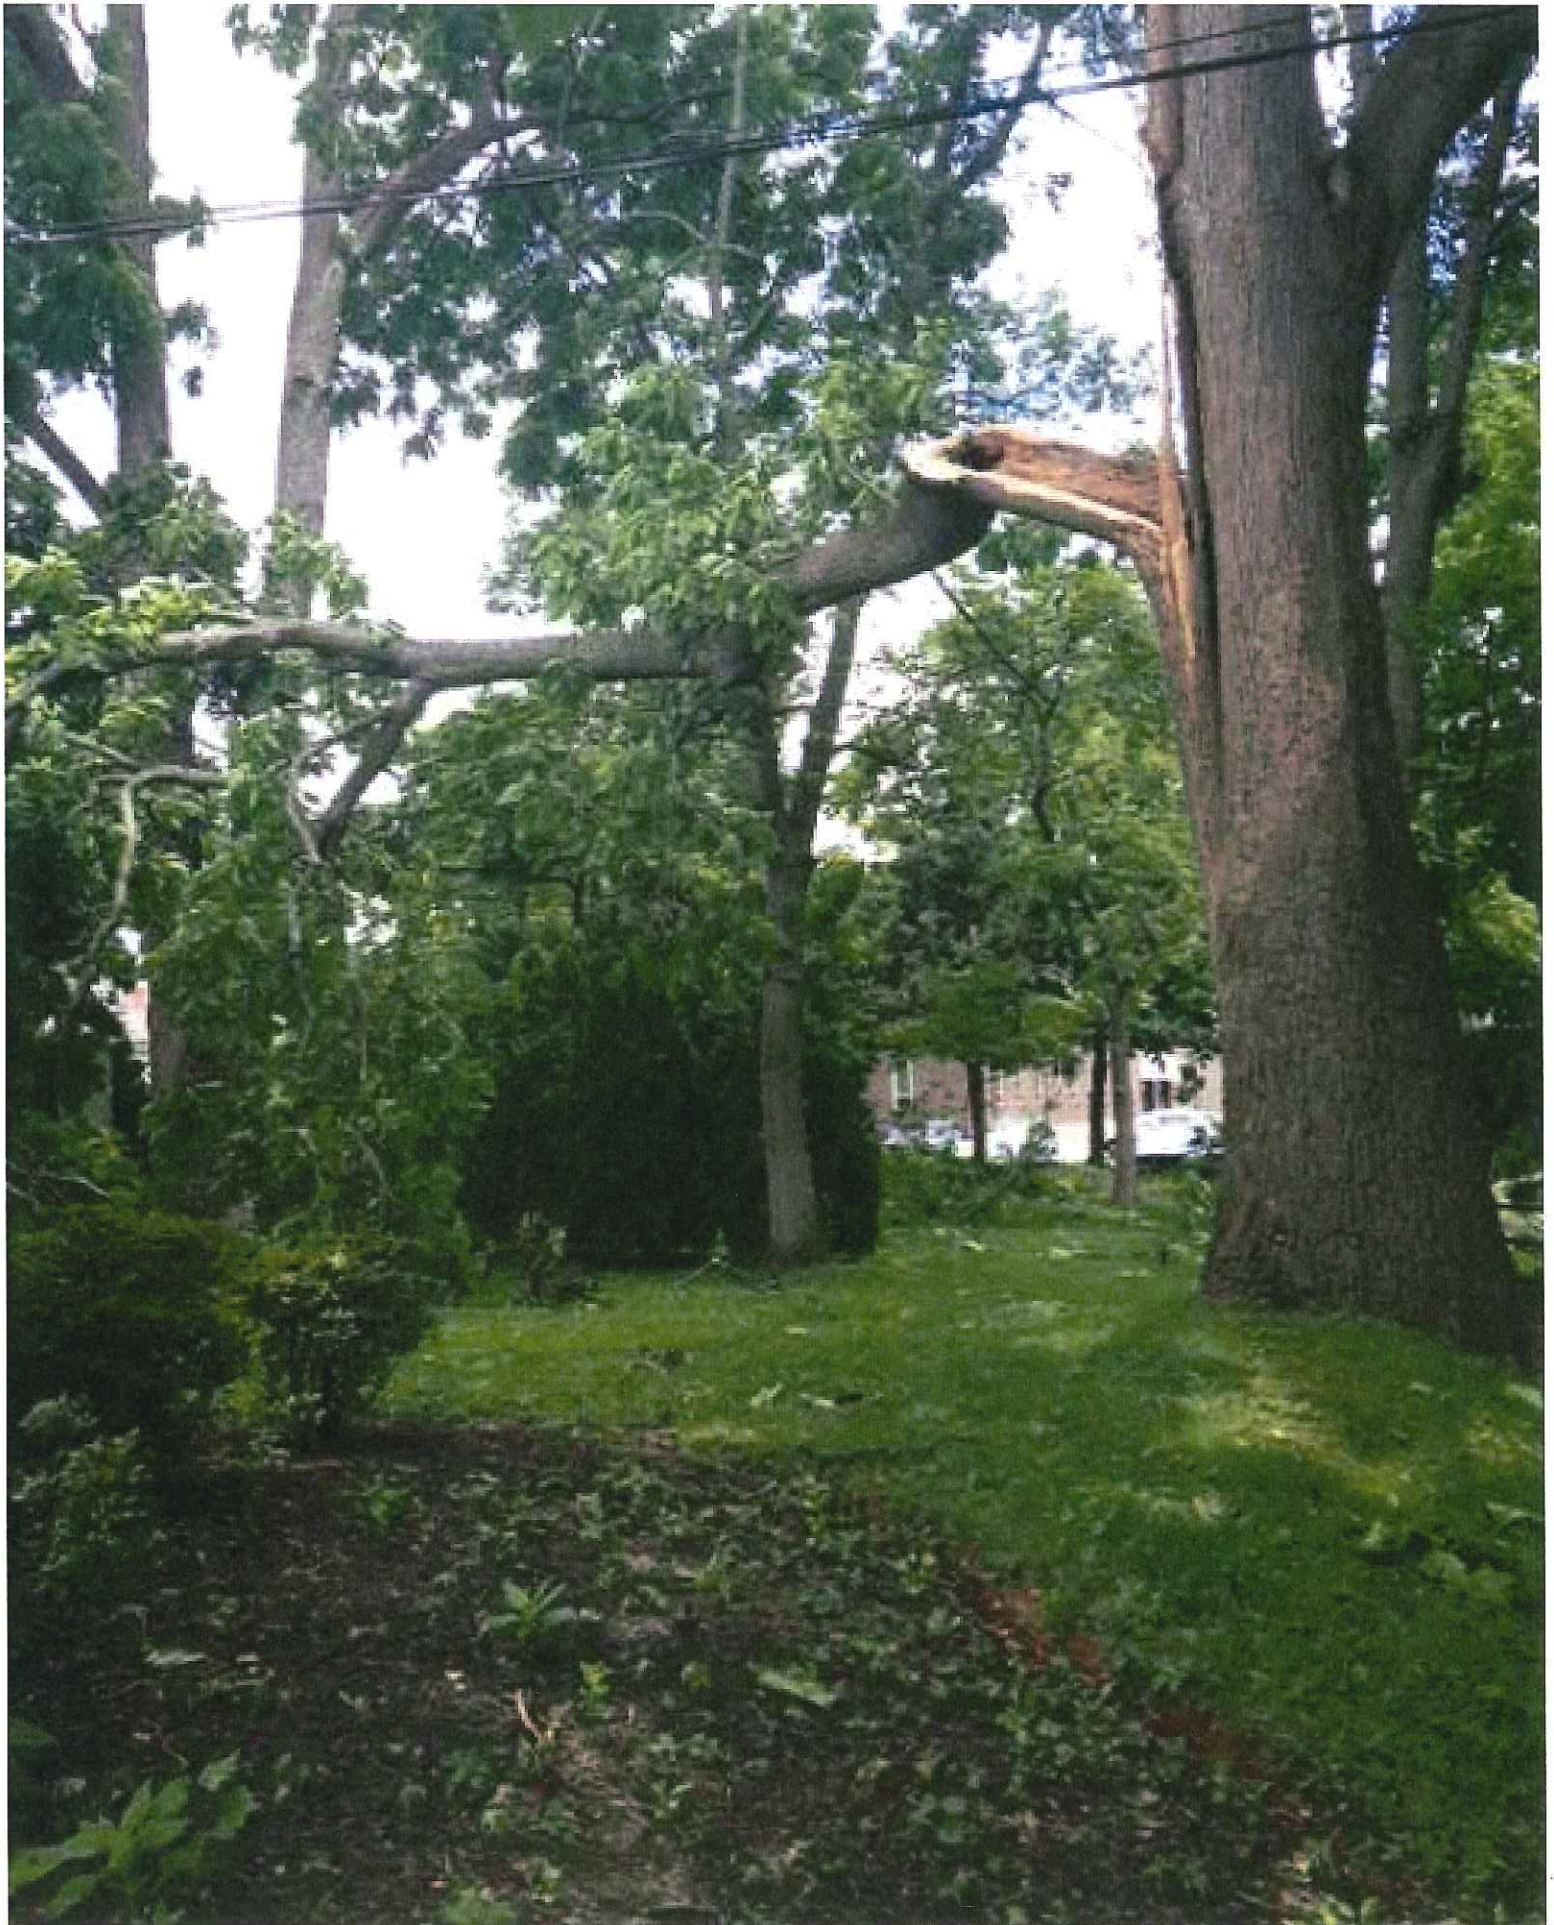
141 W Wayne

141 W. Wayne Ave Trunk becoming hollow

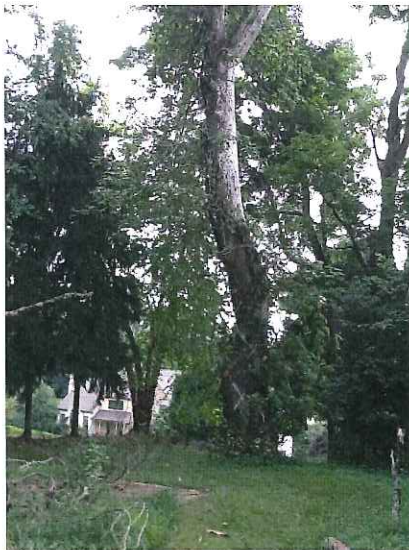
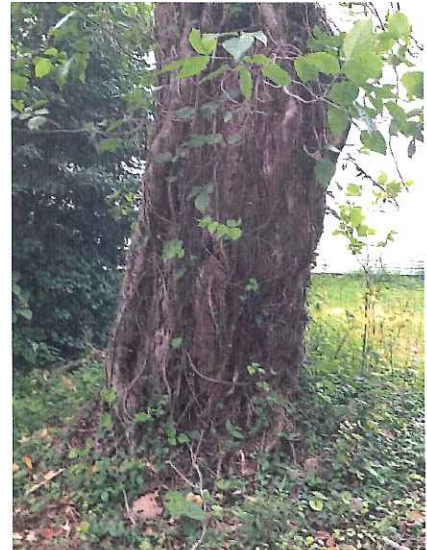
Species: *Platanus occidentalis* - Sycamore

Condition: The sycamore has several large damaged areas. The wood in the damaged areas has begun to decay and has weakened the structure. The tree will continue to decline until it fails and should be removed.

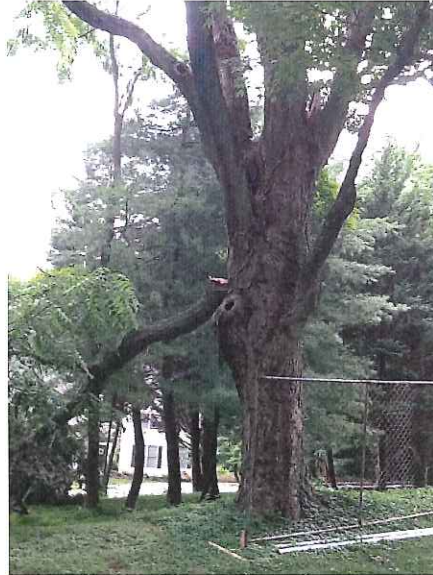
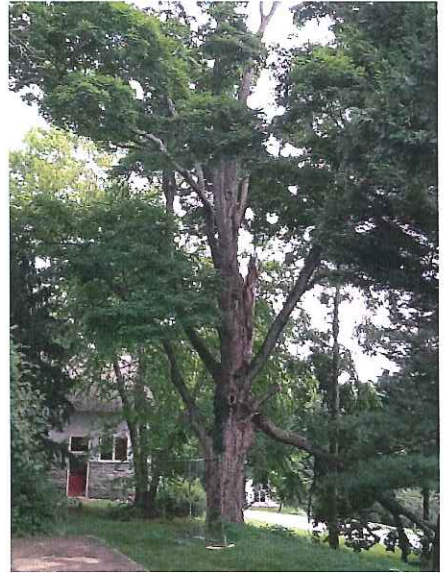
Species: Acer saccharum. DBH 34"

Condition: The Sugar Maple has a large hollow cavity in the main trunk. The decline in structure and support in the branch area has resulted in large leads and branches failing. The tree should be removed.

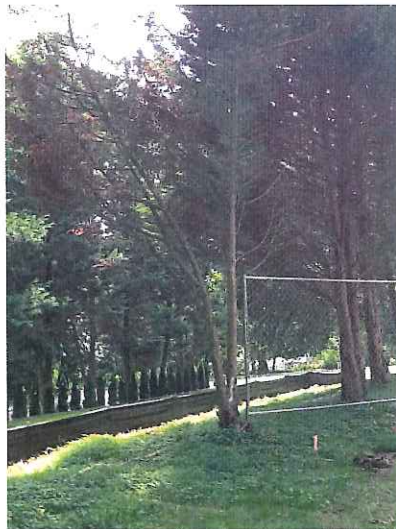
Species: Cedar - 13" DBH

Condition: Cedar is diseased and dying. Recommend removal

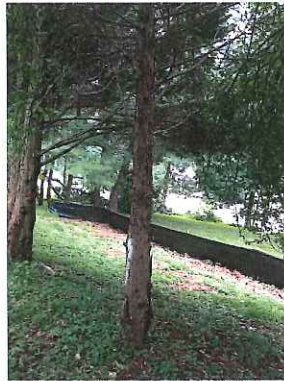
Species: Cedar - 9"DBH

Condition: Cedar is diseased and dying.
Recommend removal

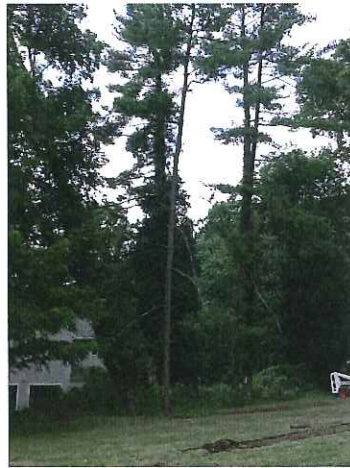
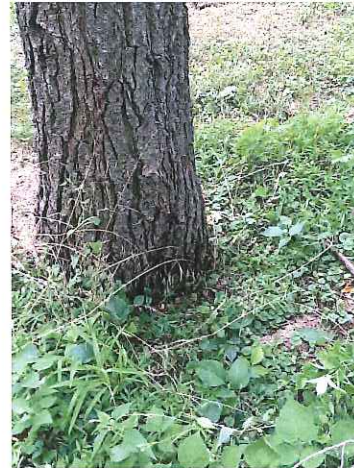
Species: Pinus strobus - 14"DBH

Condition: The white pine has a 10 degree lean. The base on the side away from the lean has a large defect, and decay is present. Recommended for removal.

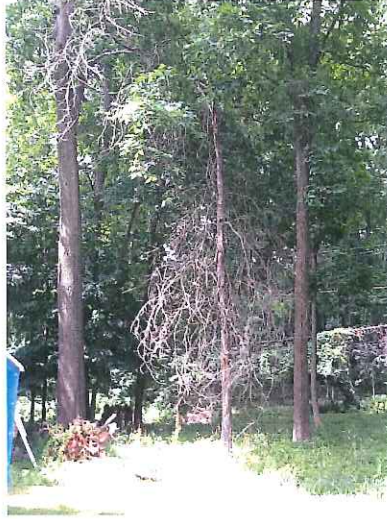
Species: unknown - Pine. 10" DBH

Condition: Dead. Removal

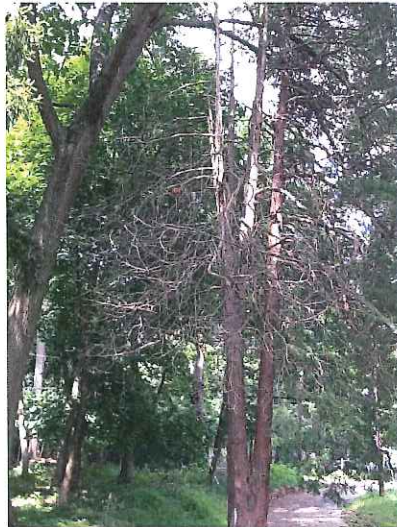
Species : Cypress 16"DBH

Condition: Over 60% dead. Recommended for removal.

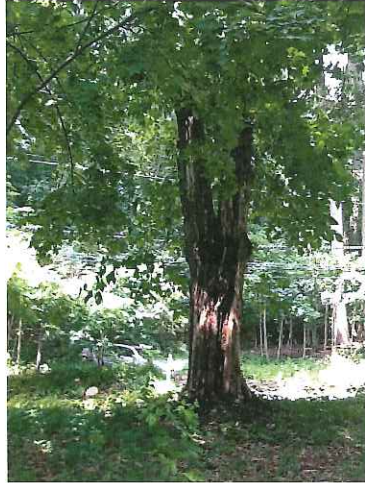
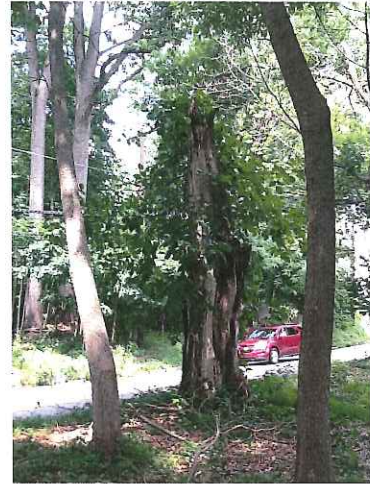
Species : unknown. Most likely Maple. Two stumps

Condition: Dead. Removal

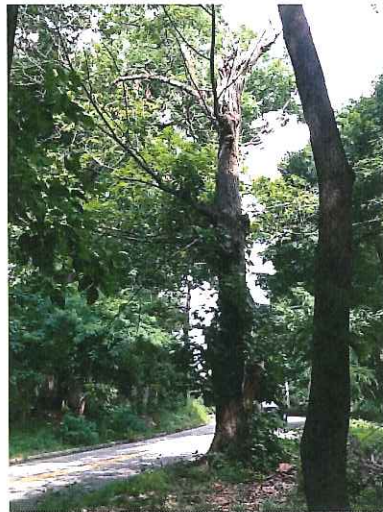
Species: *Acer platanoides*

Condition: Dead. Removal

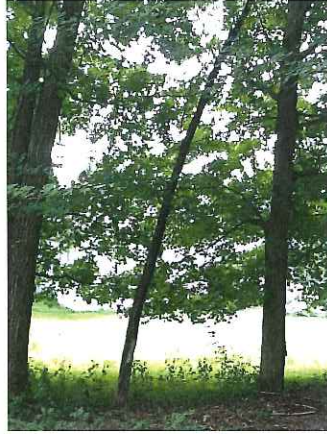
Species: unknown. 8" DBH

Condition: Dead. Removal

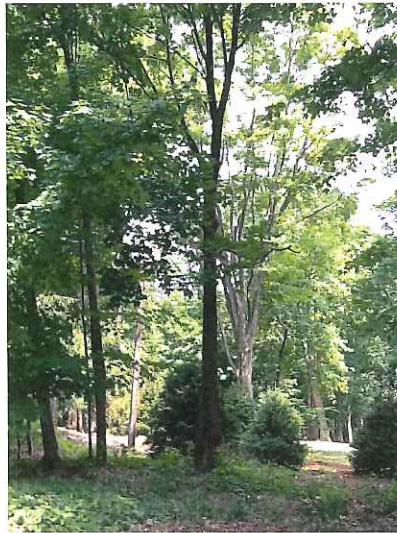
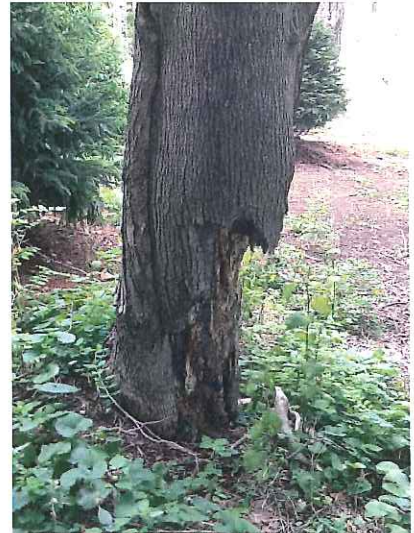
Species: *Acer platanoides*

Condition: The maple has major decay at the base. It is in danger of failing at any time. It should be removed as soon as possible.

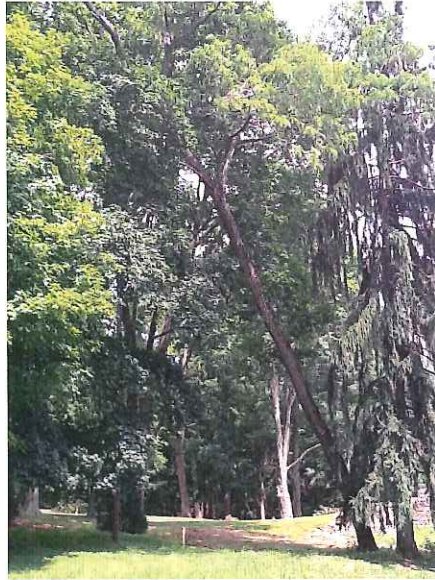
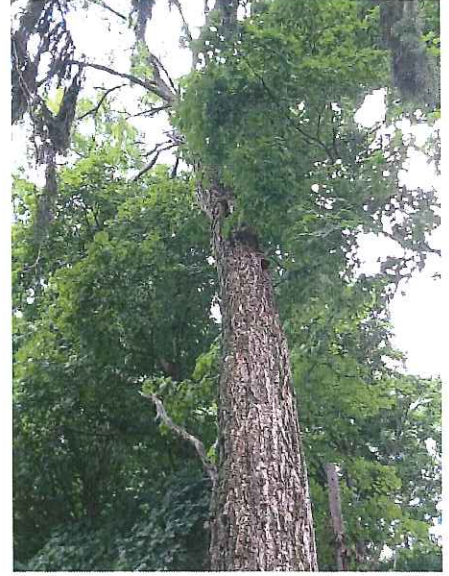
Species: Robinia pseudoacacia

Condition: The locust has a 10-15 degree lean. The back side of the trunk has a lot of damage and decay. There are fungal conks evident. Tree should be removed.

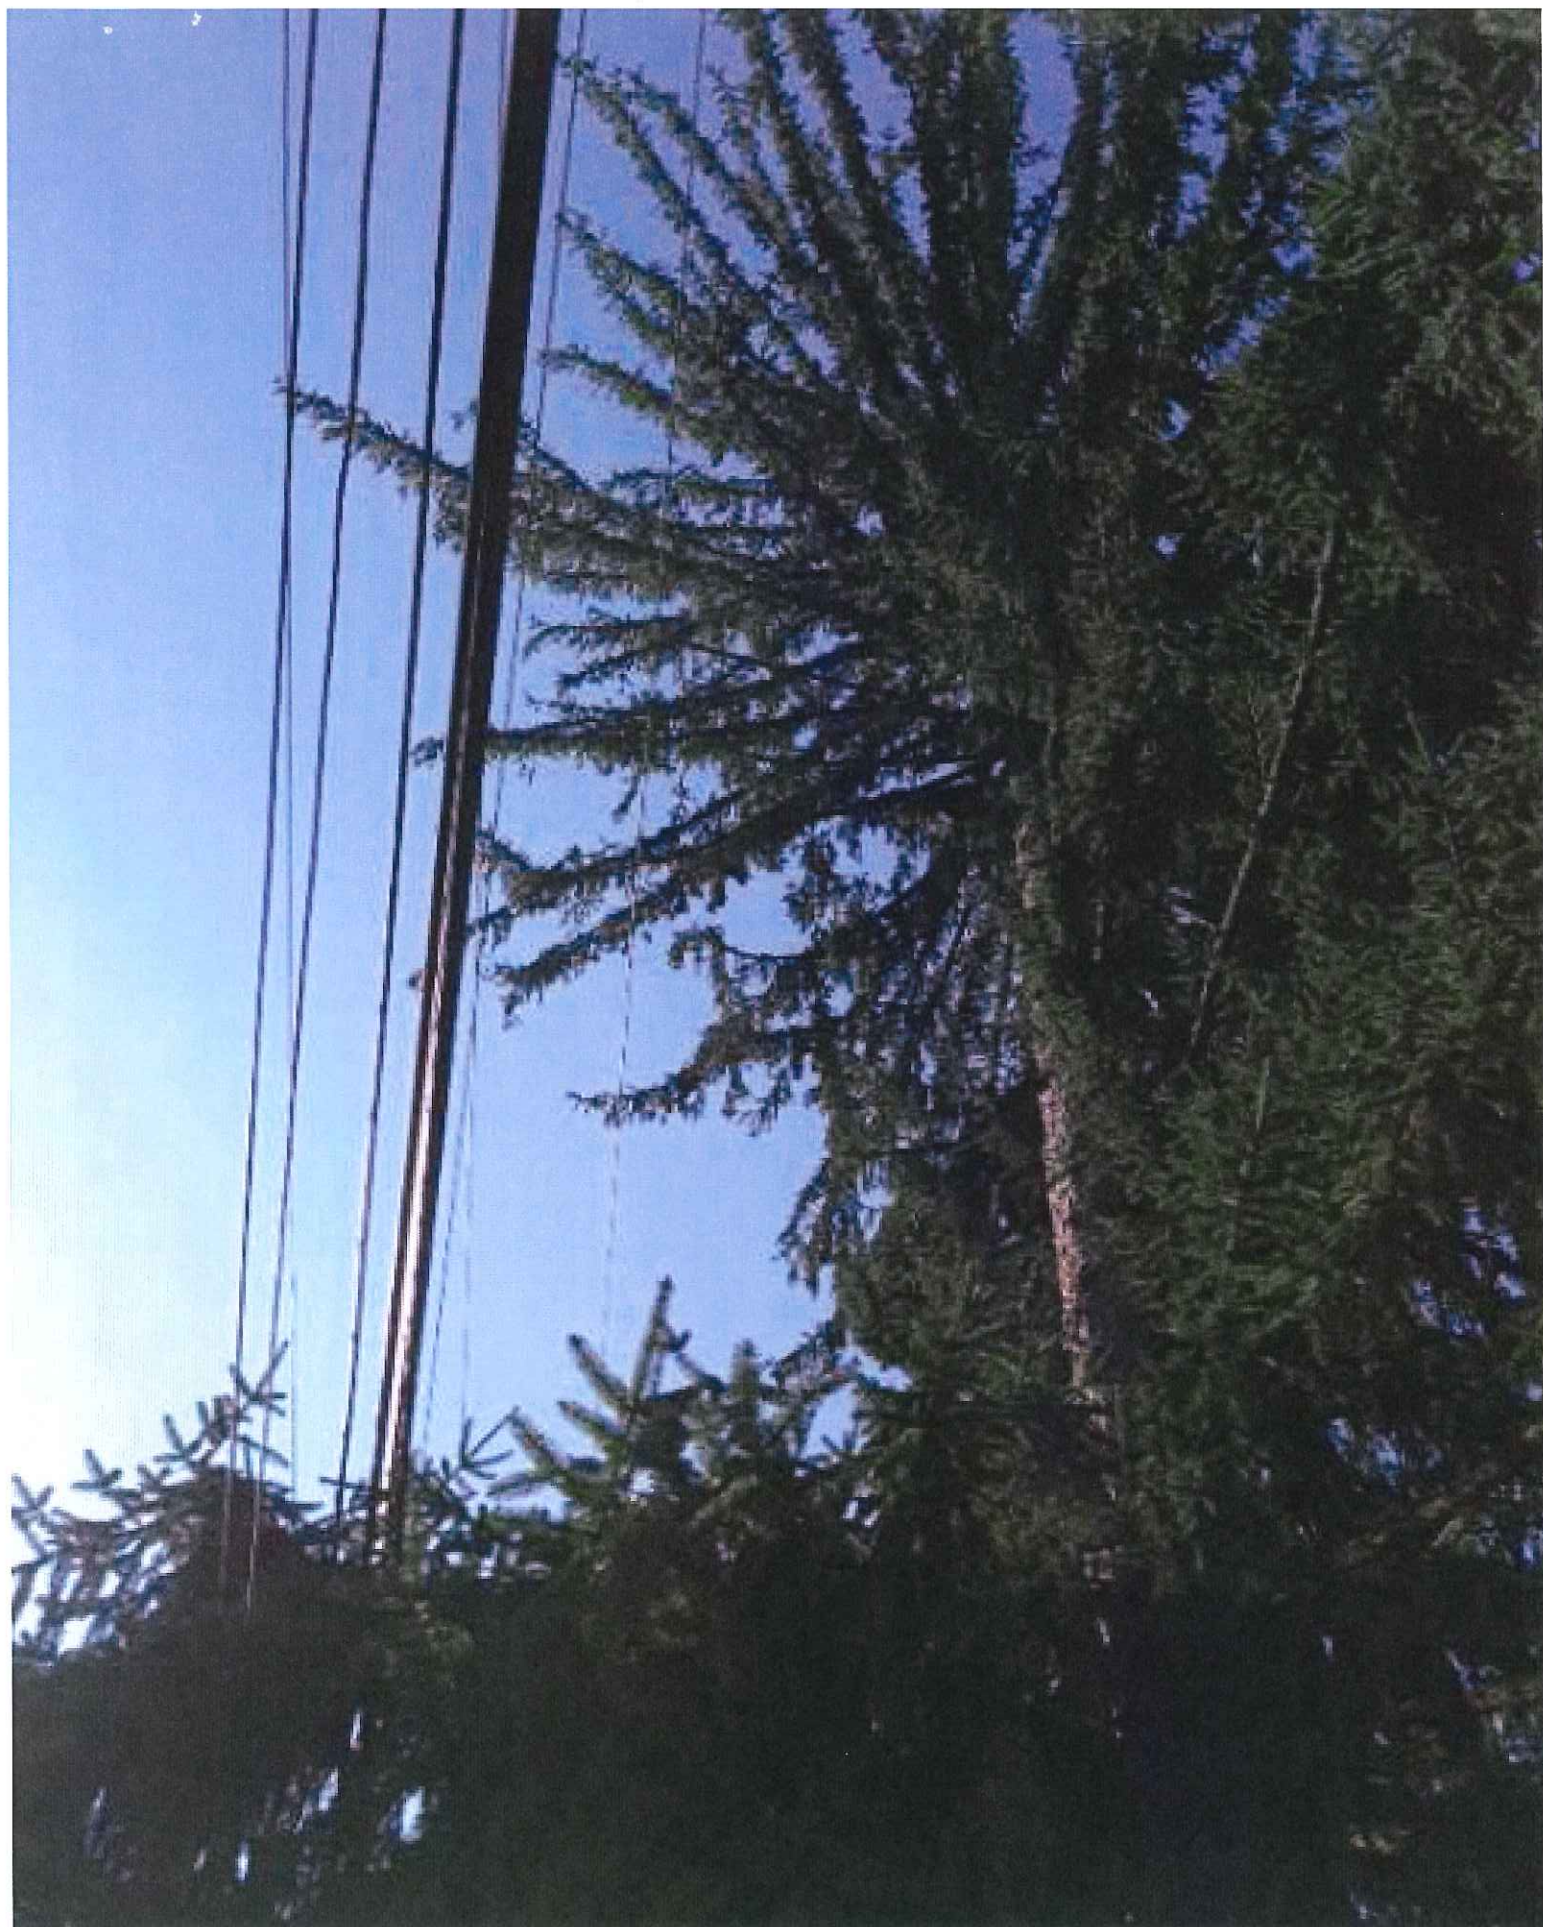
The unbalanced tree canopy due to peco pruning has
the homeowner concerned about the safety of their home if
the tree were to fail. There are irregularities in the trunk as
well, indicating the high probability of buttress rot. The tree
should be removed.

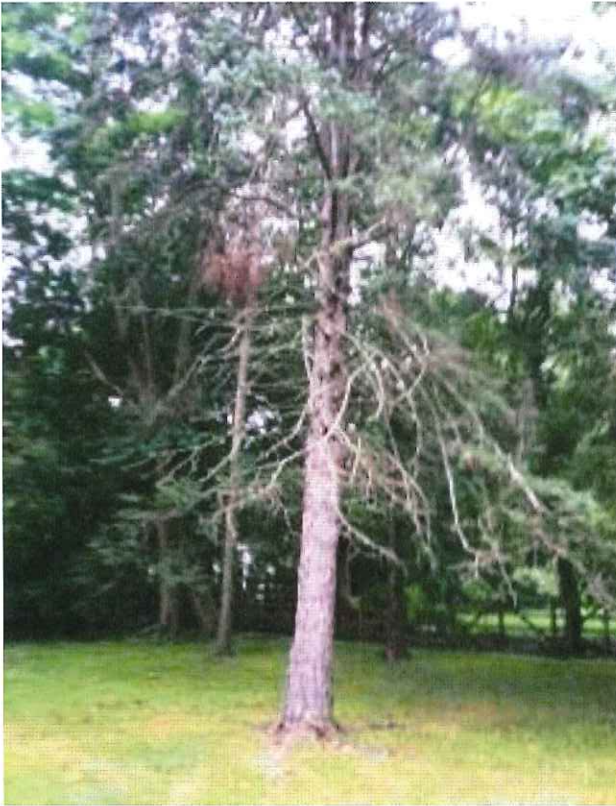
1 - 8" diameter Spruce with crown ½ dead, infected lost top 1/3rd with cytospora canker

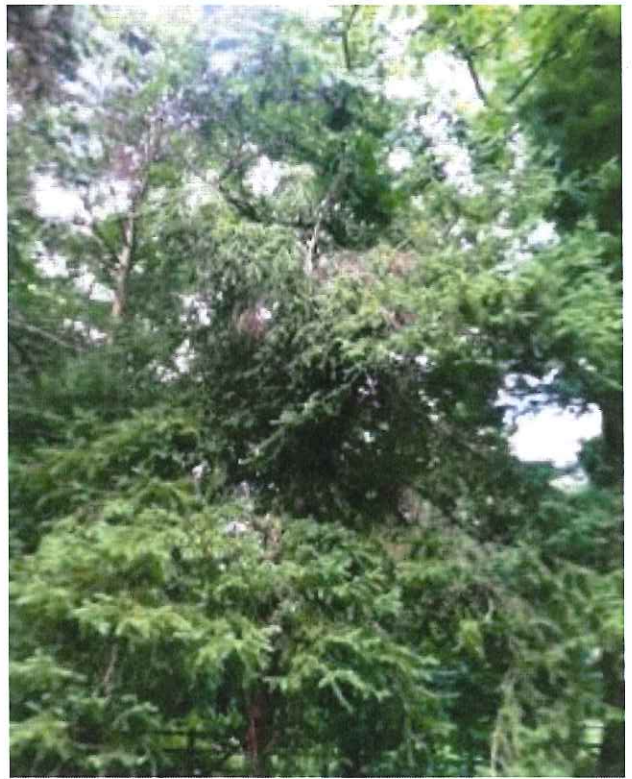
2- 7" Spruce with storm damage,

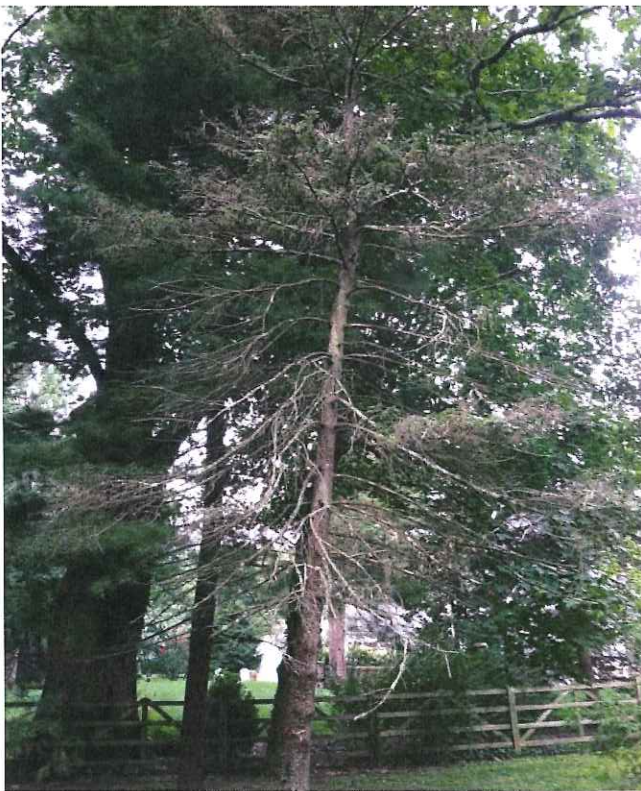
3 - 16" Spruce tree, 2/3rd dead canopy, infected with cytospora canker

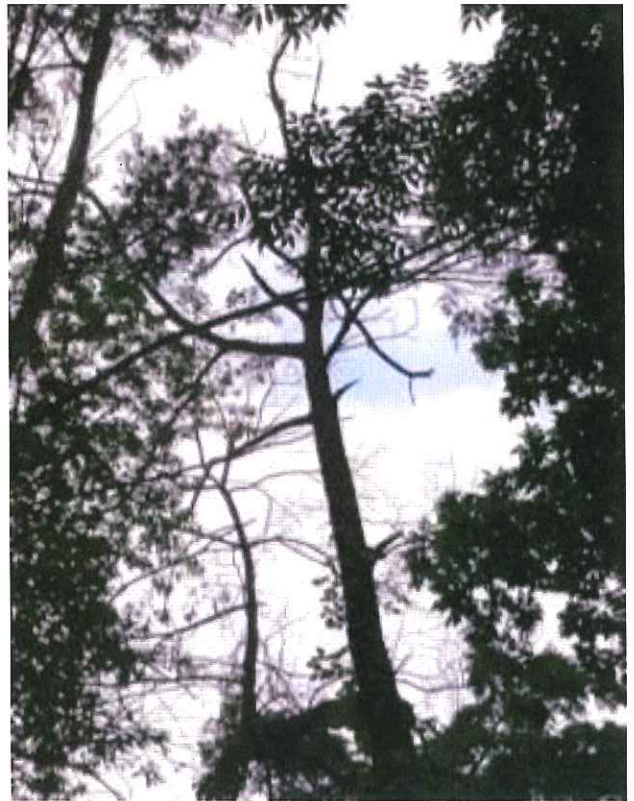
4 - 20" dead Sassafras tree

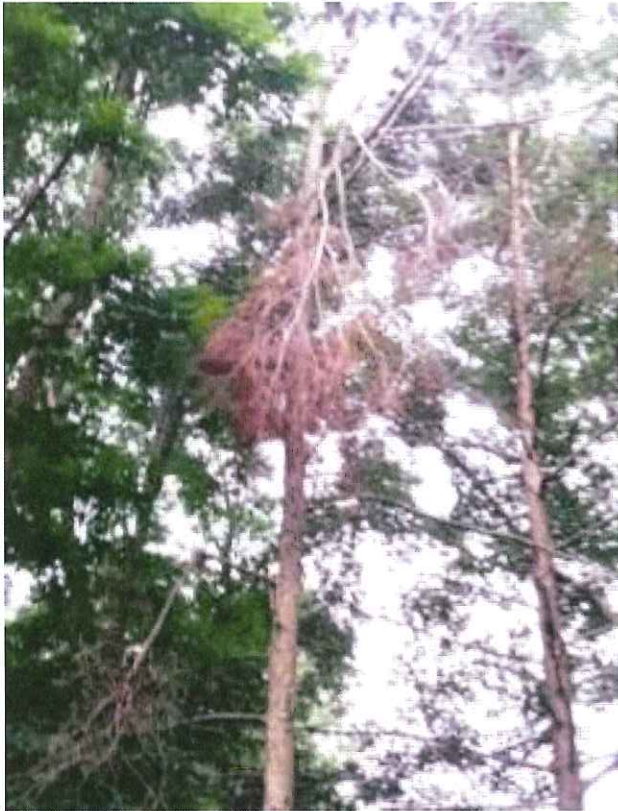
5 – 12" Hemlock, storm damaged, top 2/3rd dead with hemlock woolly adelgid and elongated scale.

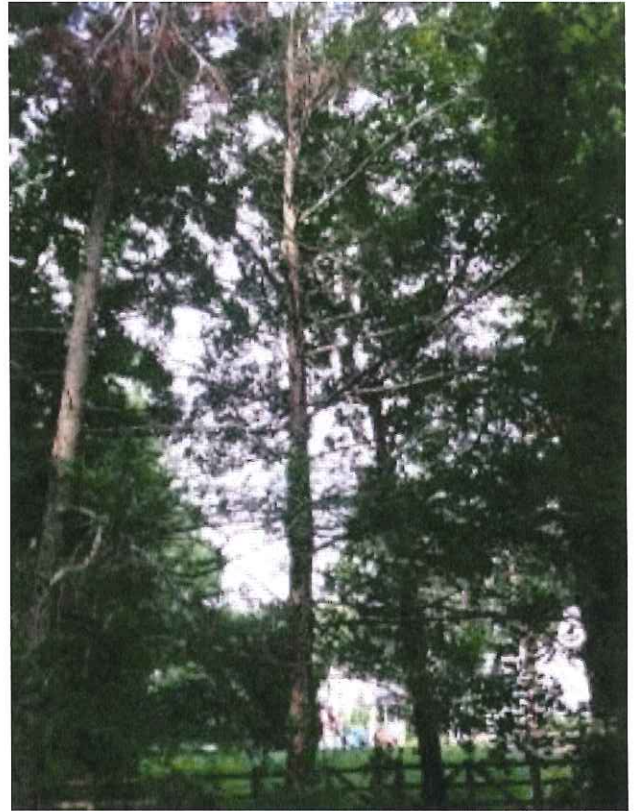
6- 12" Hemlock ½ dead, infected

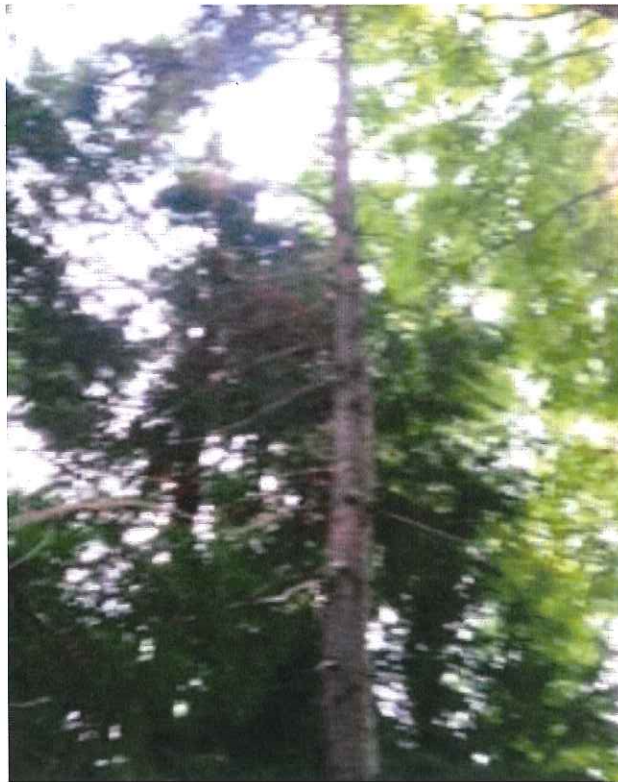
7- 6" dead Spruce tree

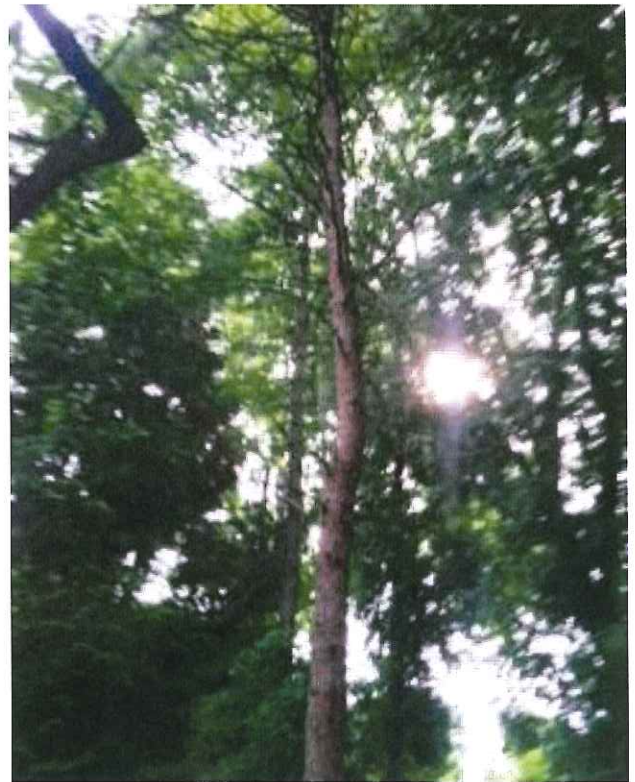
8 – 10" 90% dead Spruce tree, small amount of life at top.

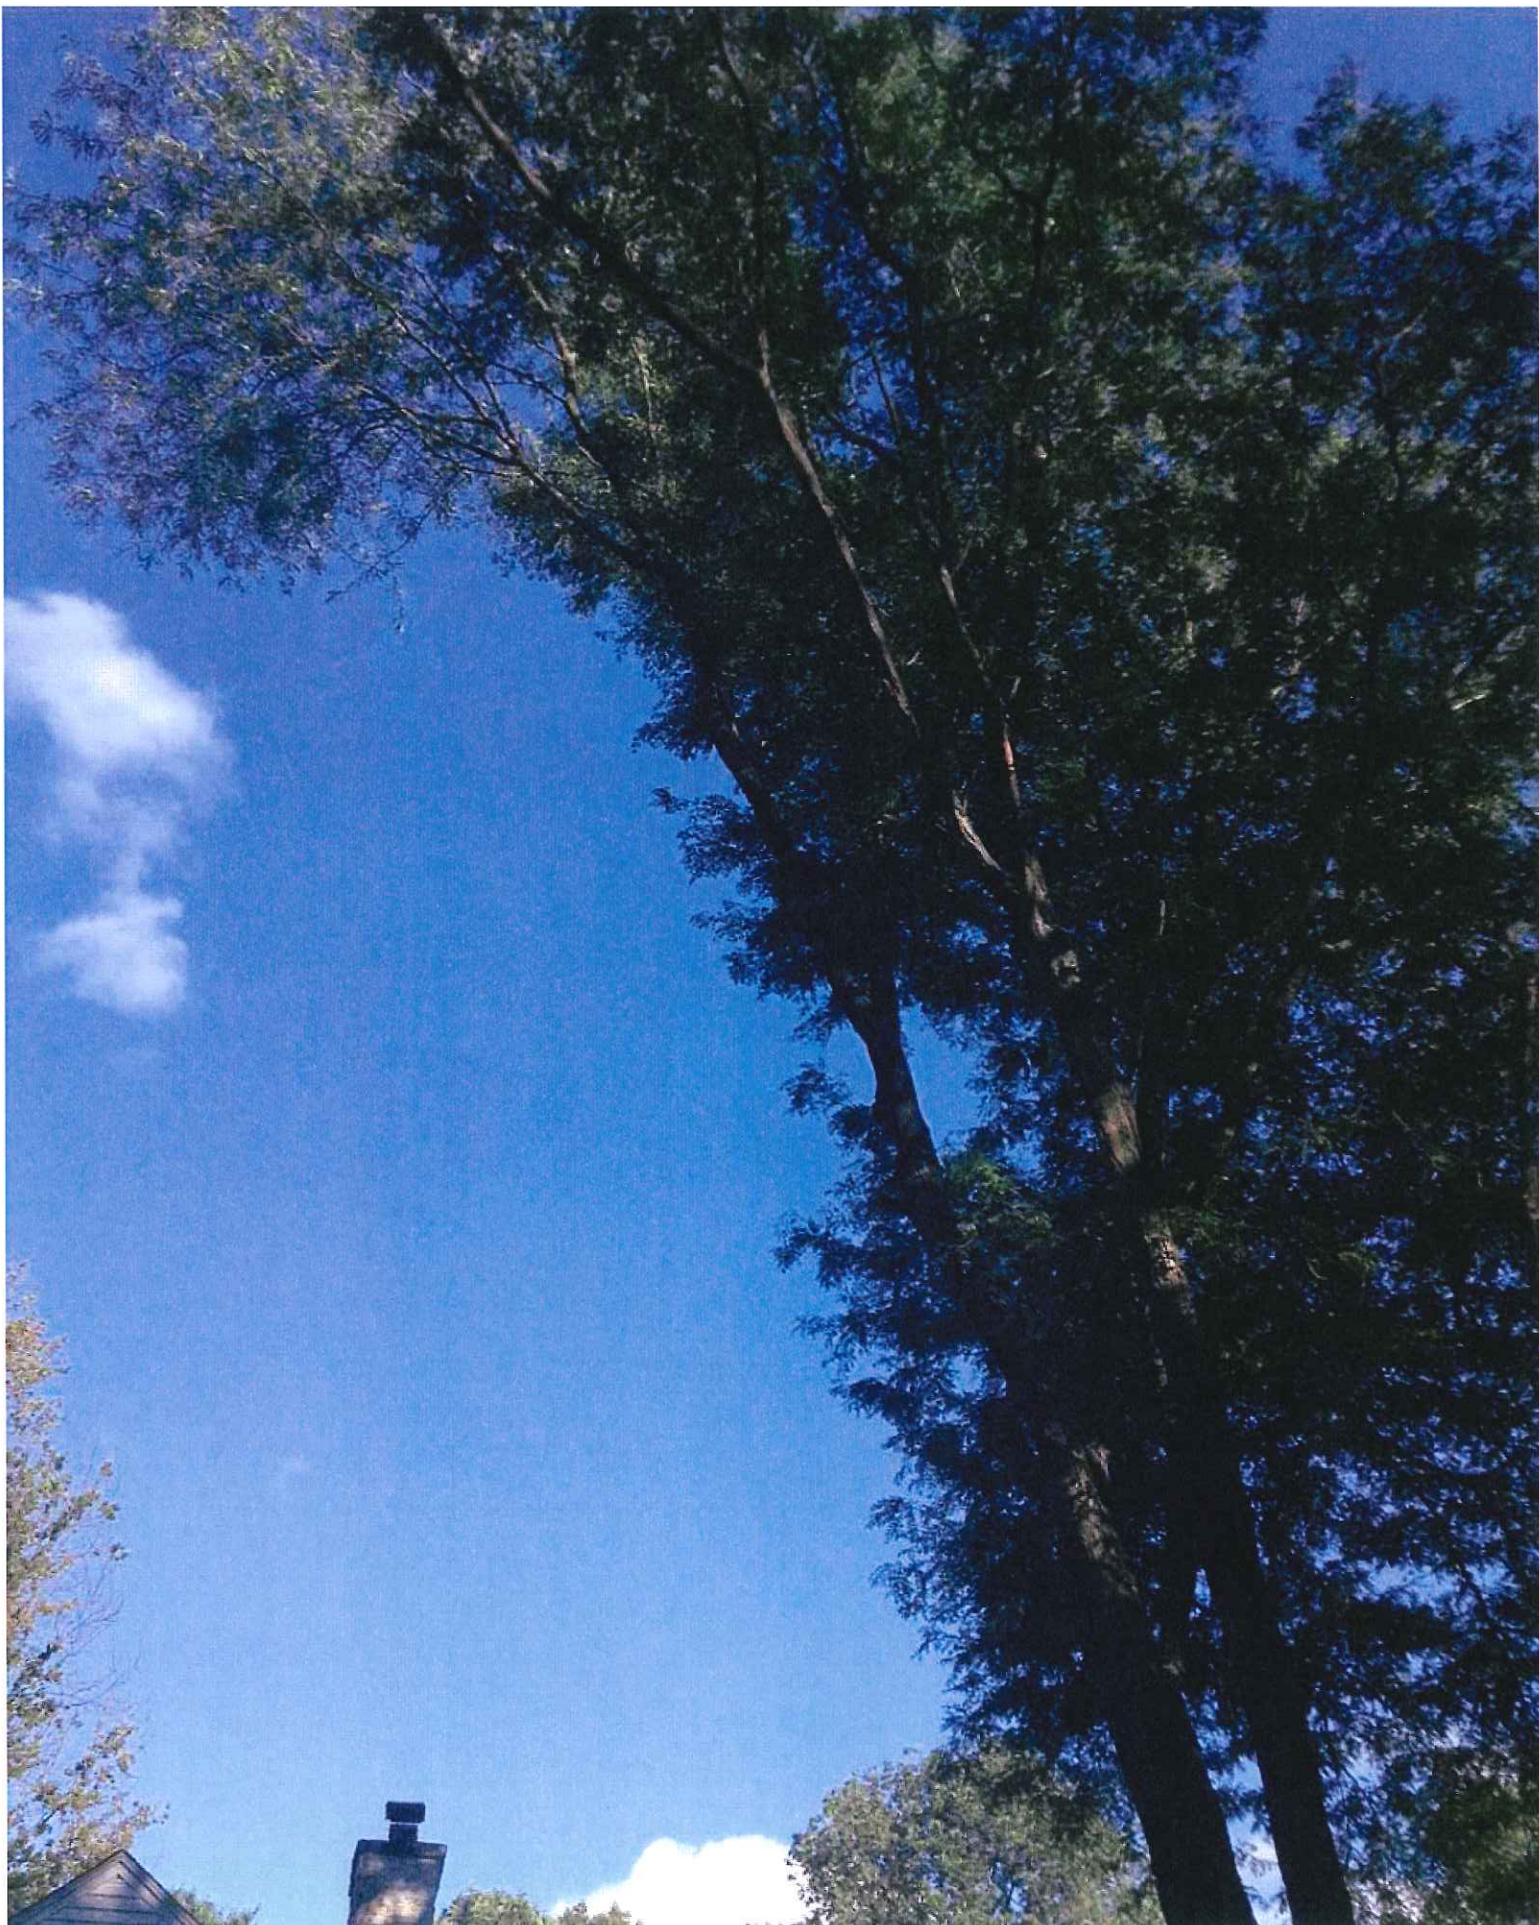
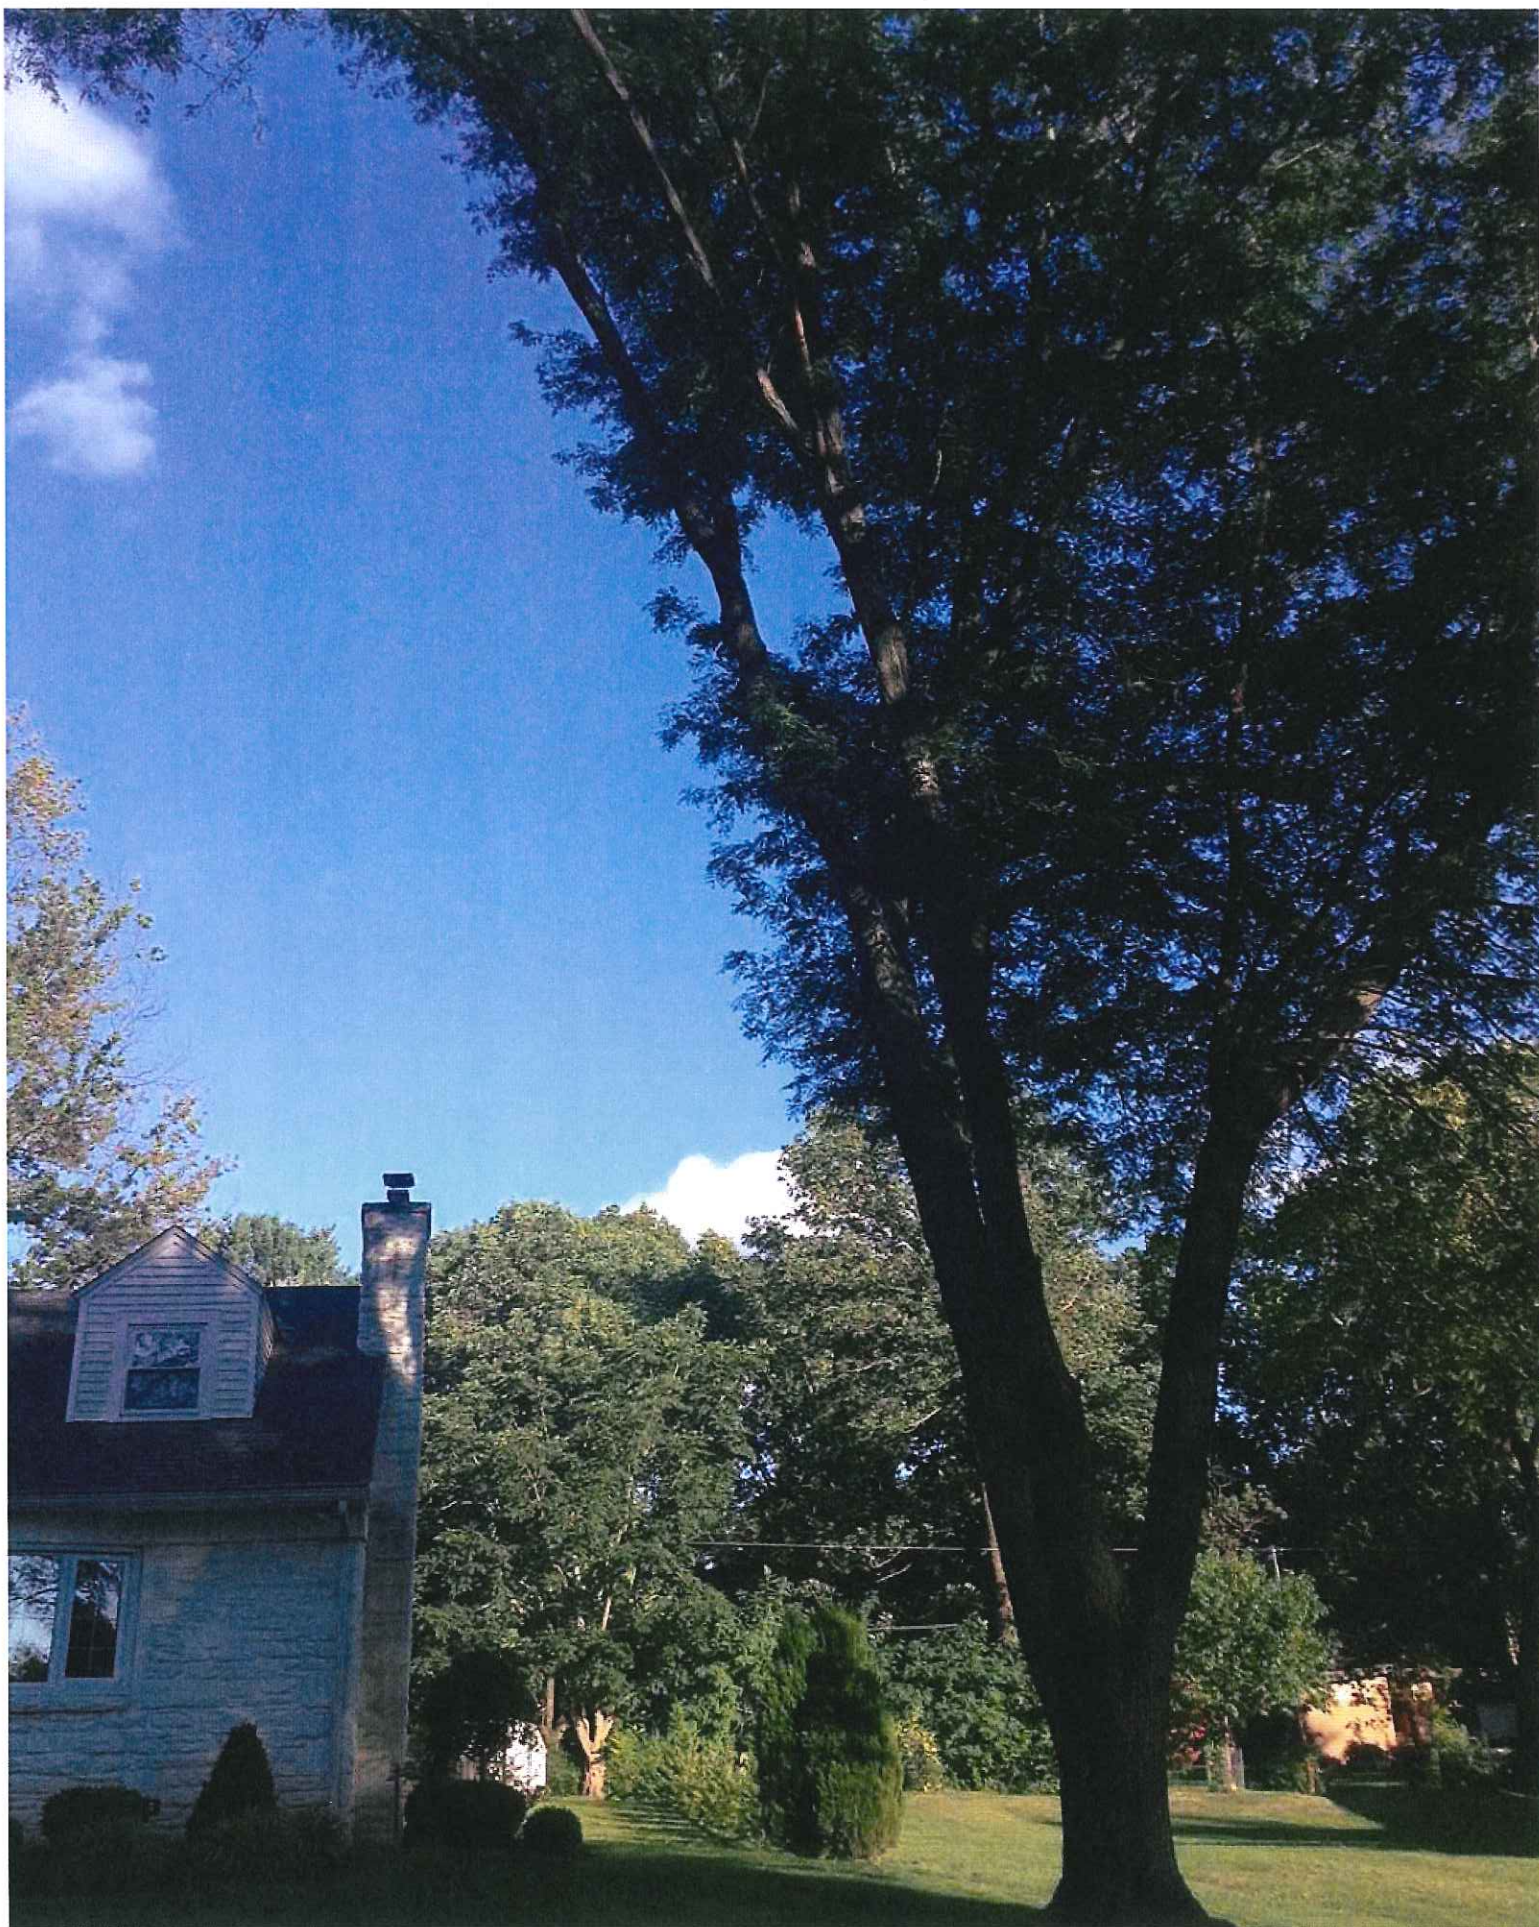
It is a 3 stem/trunk Locust removal. First picture shows the size of the limb that is fractured over the roof. Hard to see but it's about 3-4ft in length. Thanks again
