Shade Tree Commission of
Radnor Township
Wayne, Pennsylvania

AGENDA

Wednesday
August 27, 2014
6:30 PM

***Hazardous Tree Removals
Approved for removal by Township Arborist***

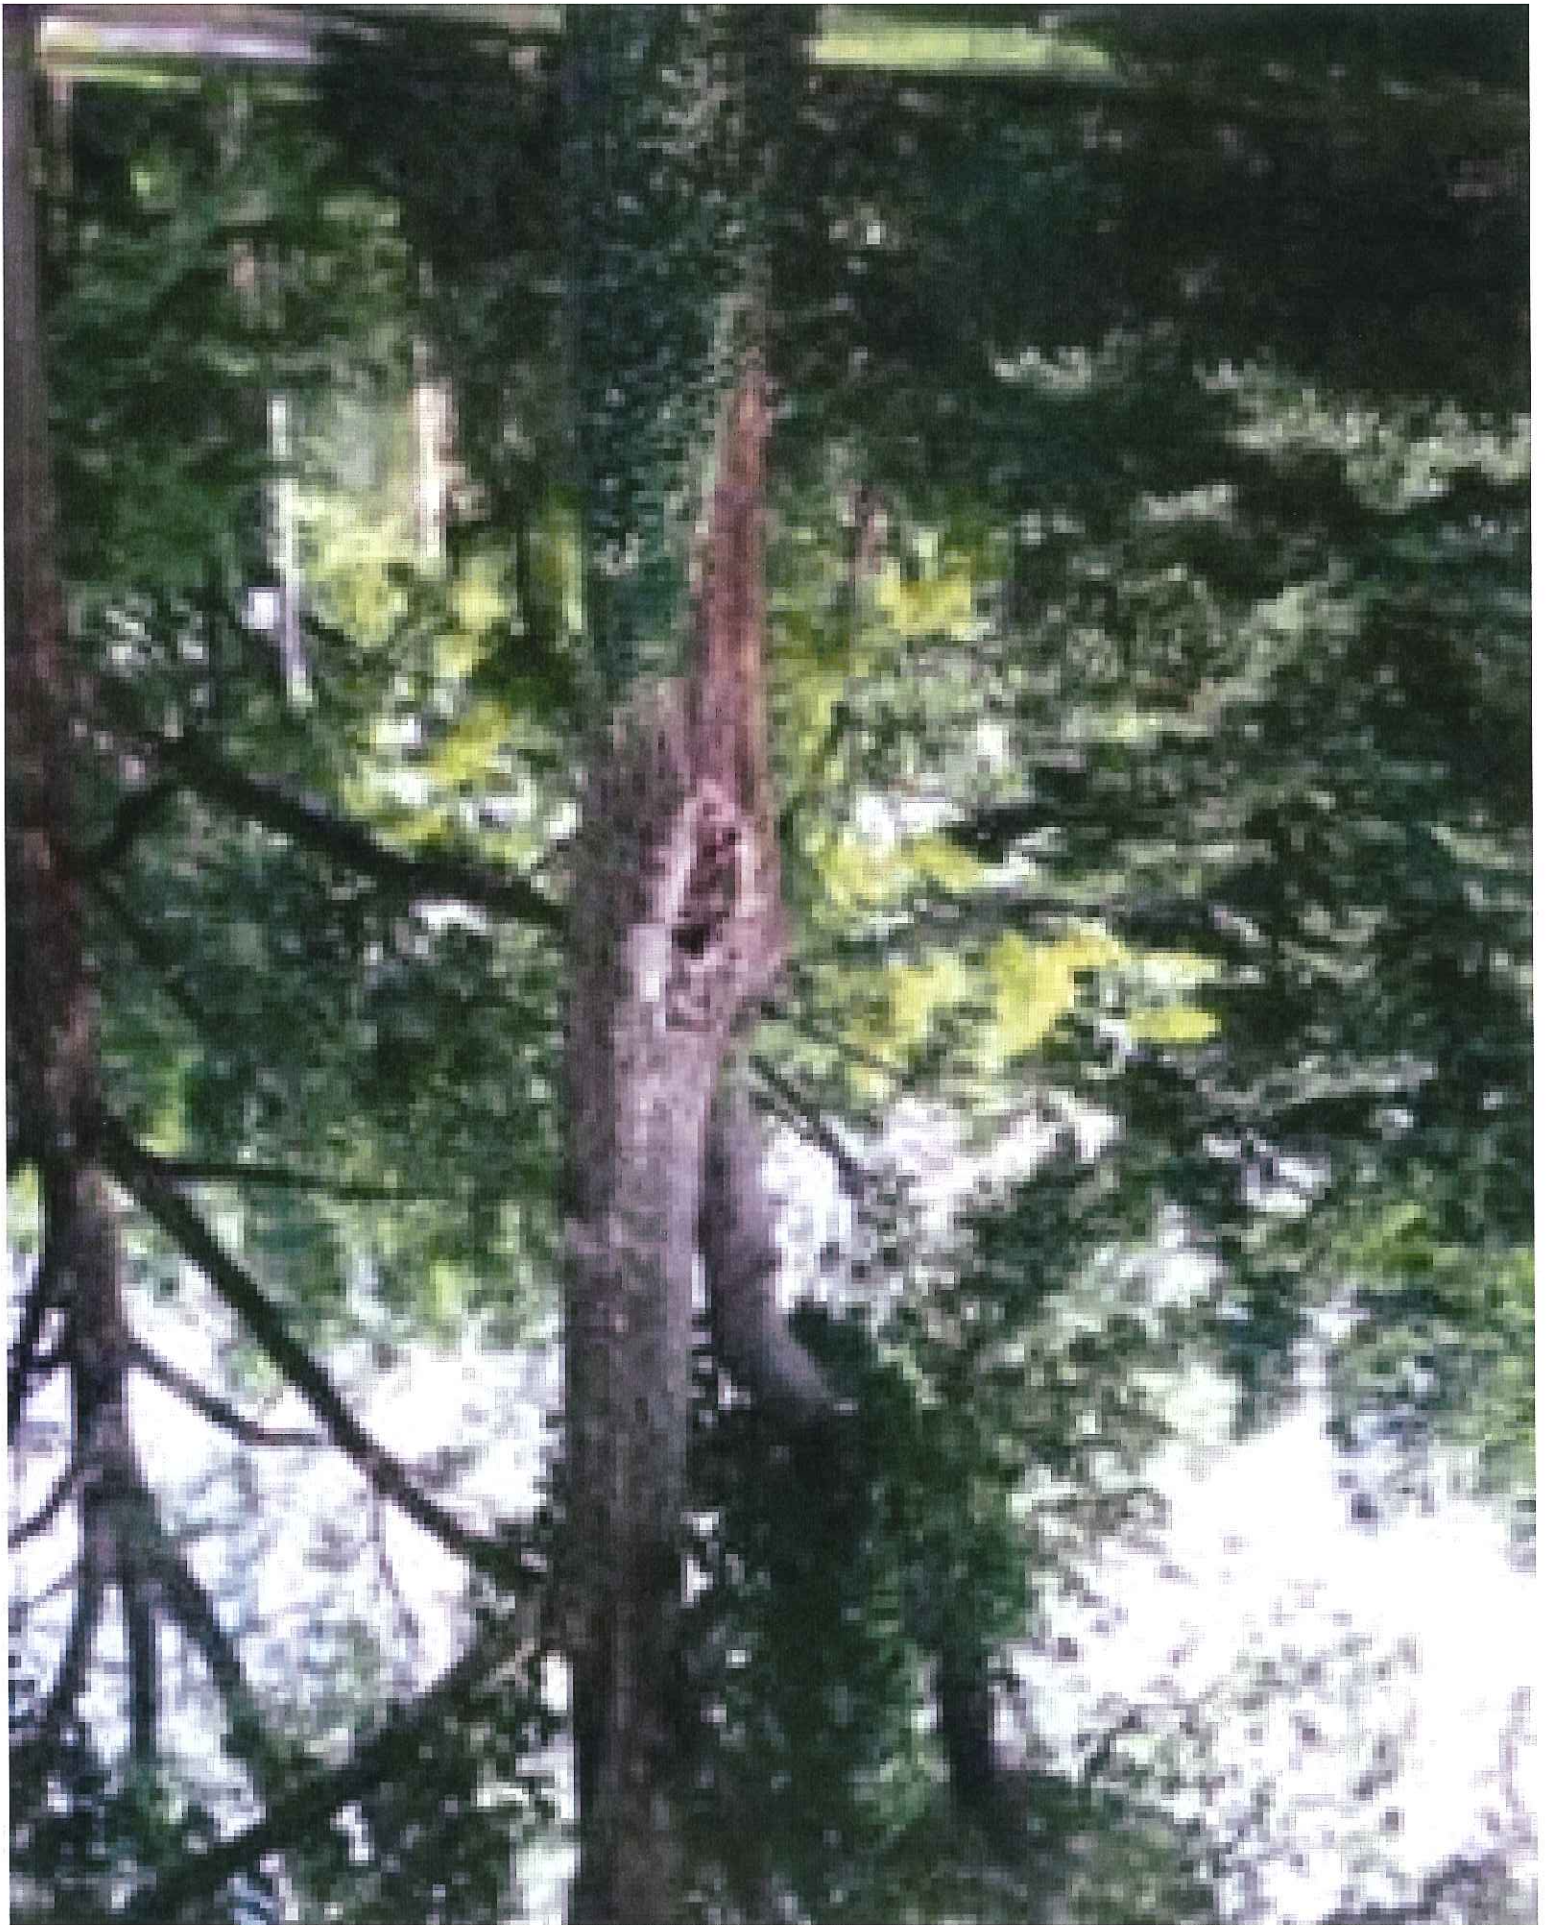
Certified arborist's narrative report (attach separate sheet if required) _____
36" dbh Tulip Poplar has a large, decayed cavity in the trunk
