FENIMORE WOODS IMPROVEMENT PROJECT

Board of Commissioners Community Development Subcommittee Meeting
Wednesday, June 23, 2021

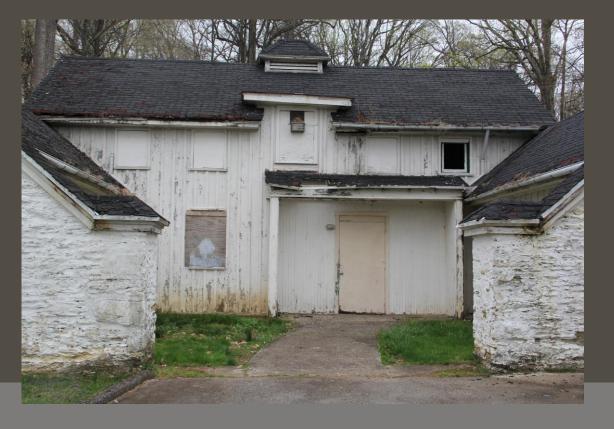
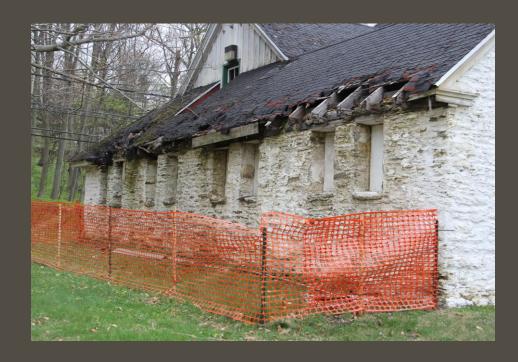
Aging Infrastructure Safety Aesthetics

- **Deteriorated Stable Building**
- Former Park Bathroom Space / Closed to Public Access in 2010 Replaced with Portable Toilettes
- Structurally Unsound Unsafe Space to Enter
- Lack of Sanitary Sewer System

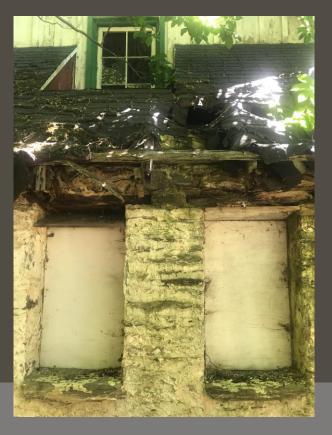
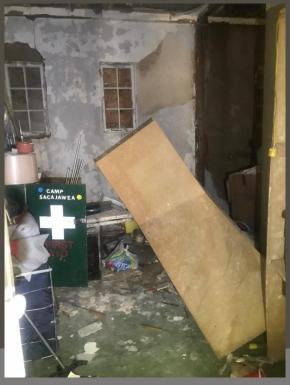
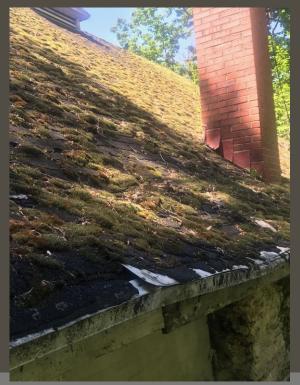
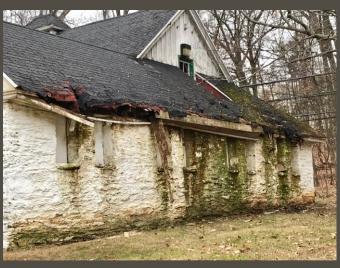
Aging Infrastructure Safety Aesthetics

- Extensive Water Damage Exterior & Interior
- **Building Systems Compromised**
- Hazardous / Environmental Conditions
- Unsafe Location for Park Users Relative to Park Gathering Spaces
- Inconspicuous Space / Attractive Nuisance

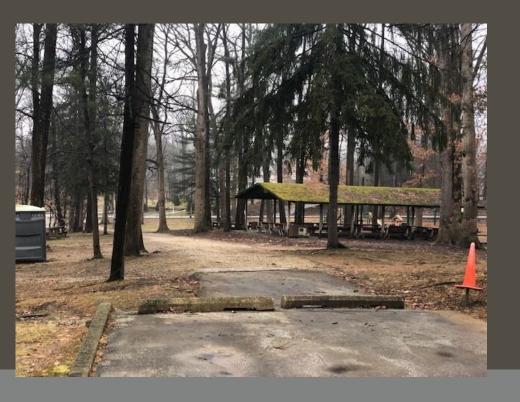
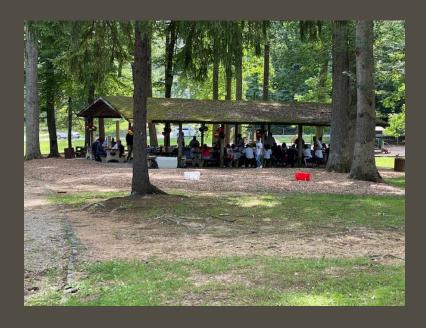
Aging Infrastructure Safety Accessibility

- Pavilion with picnic tables (Over 30 Years Old)
- Pavilion Deterioration / Failing Roof Structure / Moss
- Cracked / Uneven Concrete Surface
- Proximity to Trees / Falling Limbs
- No Accessibility or Defined Access Route from parking lots
- No Sanitary Bathroom Access Portable toilettes

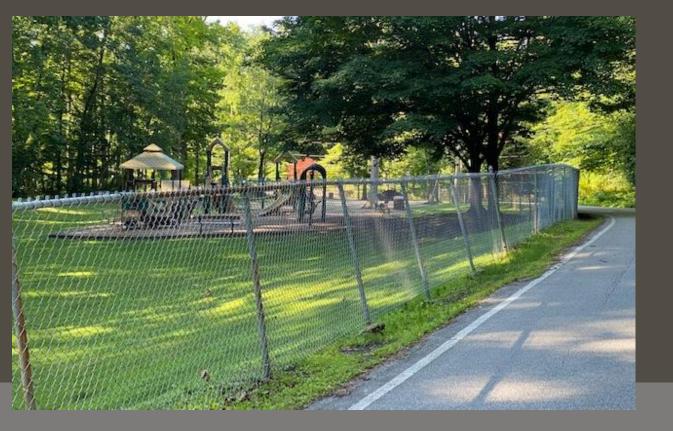
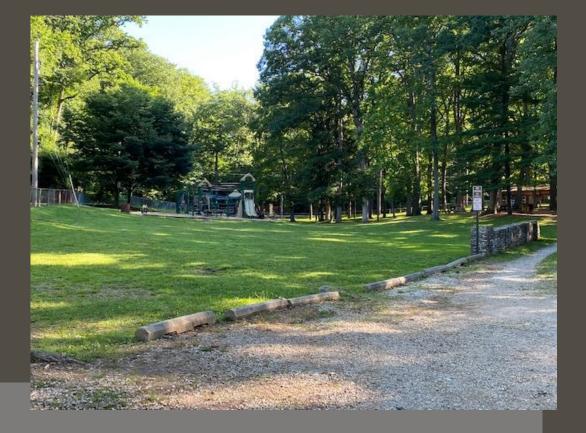
Safety Accessibility Aging Infrastructure

- Playground constructed in 2002 (Equipment breakdowns occurring across park system)
- Proximity to Paul Road
- Excessive Grade Change across playground 6'+
- Does not meet ADA / No Accessibility
- Lacks Inclusive Play Features

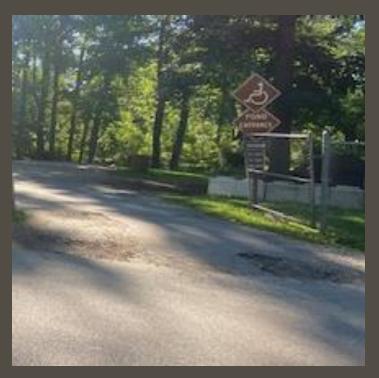
SECTION CUT LOCATION

FENIMORE WOODS - EXISTING PLAYGROUND SECTION

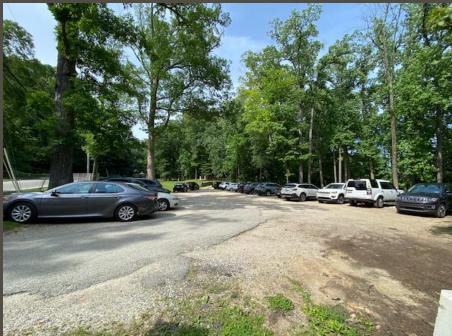
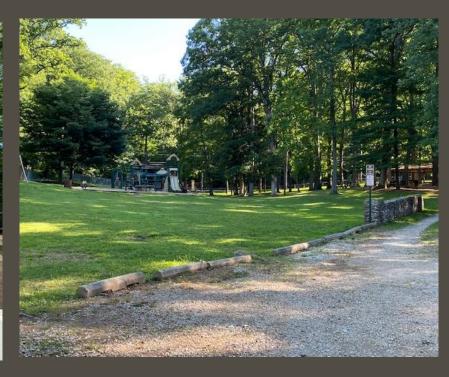
Site Access / Parking Safety Accessibility

- Lower Parking Lot Access Dangerous Intersection where park entrance, Paul Road, Walnut Avenue Converge
- Undefined Parking Configuration & Entrance to Upper Park
- Mixed Surfaces / Potholes / Eroding Lot Border
- No Accessibility / Does not meet ADA
- Steep 'Step Down' to Access Pond

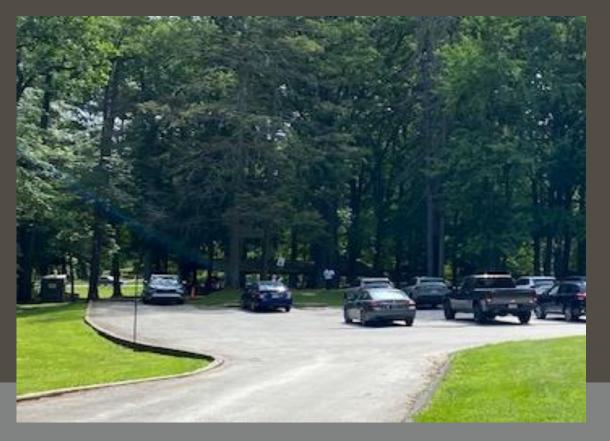
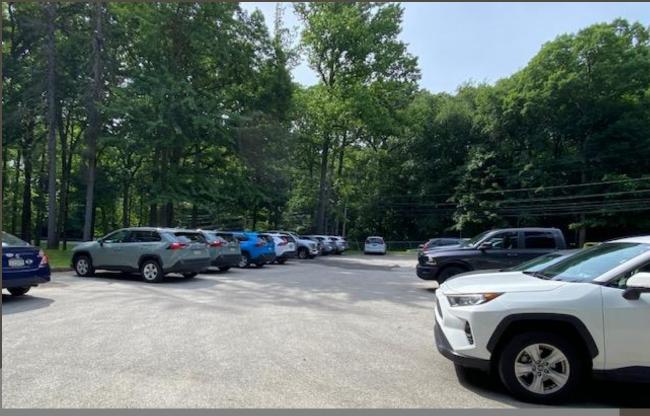
Site Access / Parking Safety Accessibility

- Necessary Parking to Accommodate the Usage
- Upper Parking Lot Undefined Parking Configuration and Traffic Flow
- No Accessibility to Pavilion
- Steep 'Step Down' to Access Open Space Area

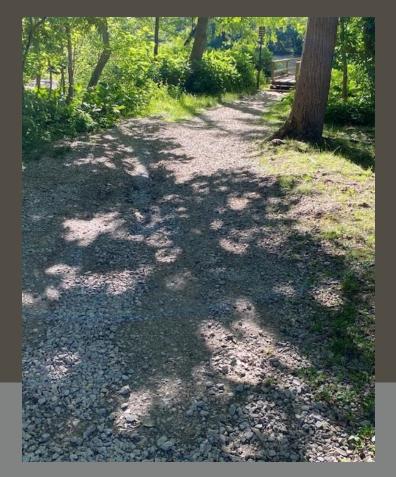
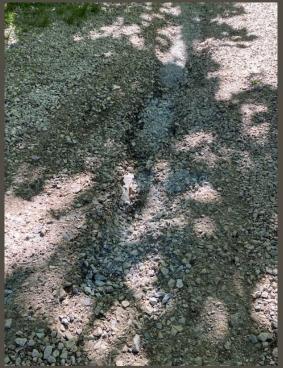
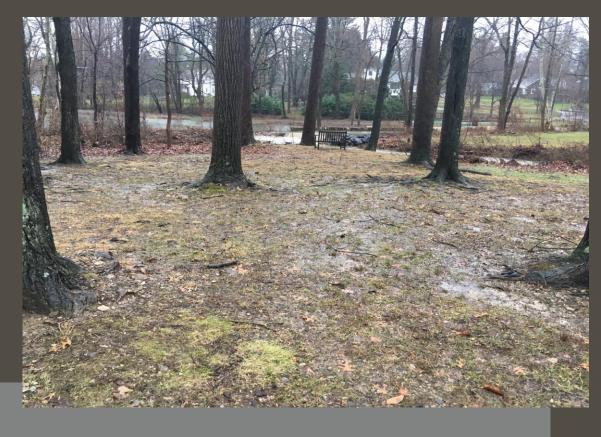
No Stormwater Management

- No Control of Run Off from Existing Park Amenities & Surfaces or to Gulph Creek
- Exposed Tree Root Systems / Trip Hazards
- Pond Walking Path Deterioration
- Site Erosion Impacts and Increases to Grades Over Time

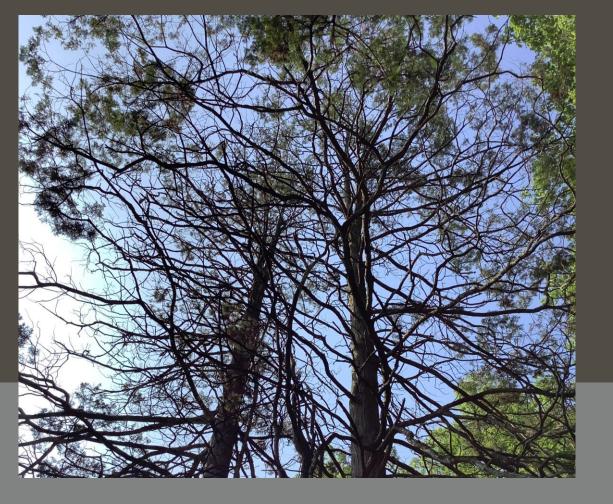
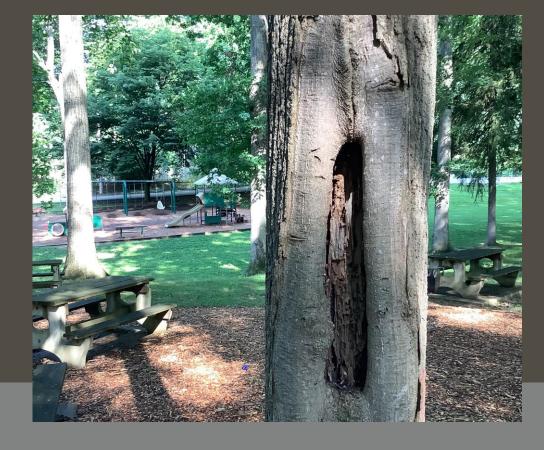
Tree Safety

- Near-Misses to User Groups with large branches falling onto / near the recreational spaces
- Mitigation Efforts Needed Related to Safety
- Exposed Tree Root Systems due to Site Erosion
