CONDITION ASSESSMENT REPORT FOR

THE WILLOWS

A PROPERTY OWNED BY RADNOR TOWNSHIP, PENNSYLVANIA

Avison Young

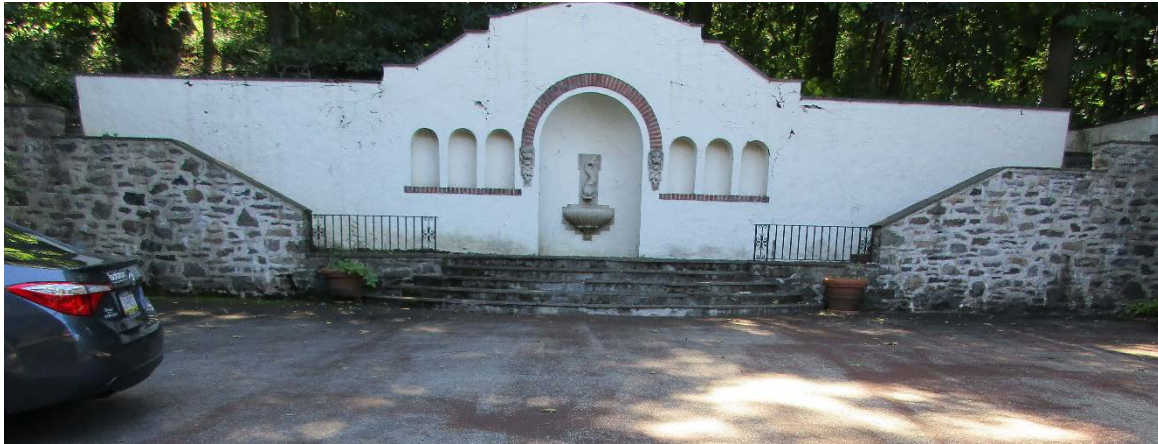
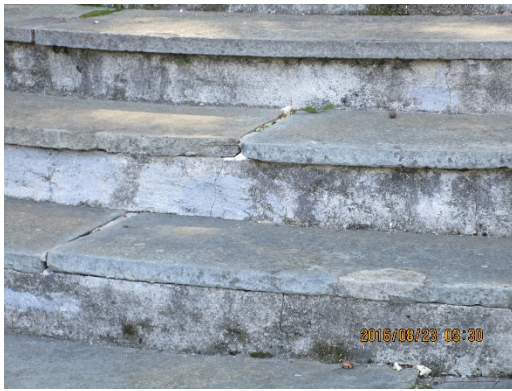
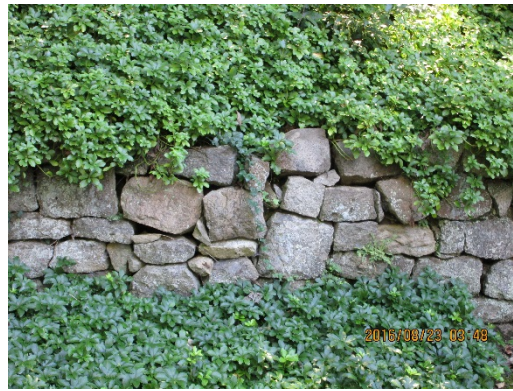
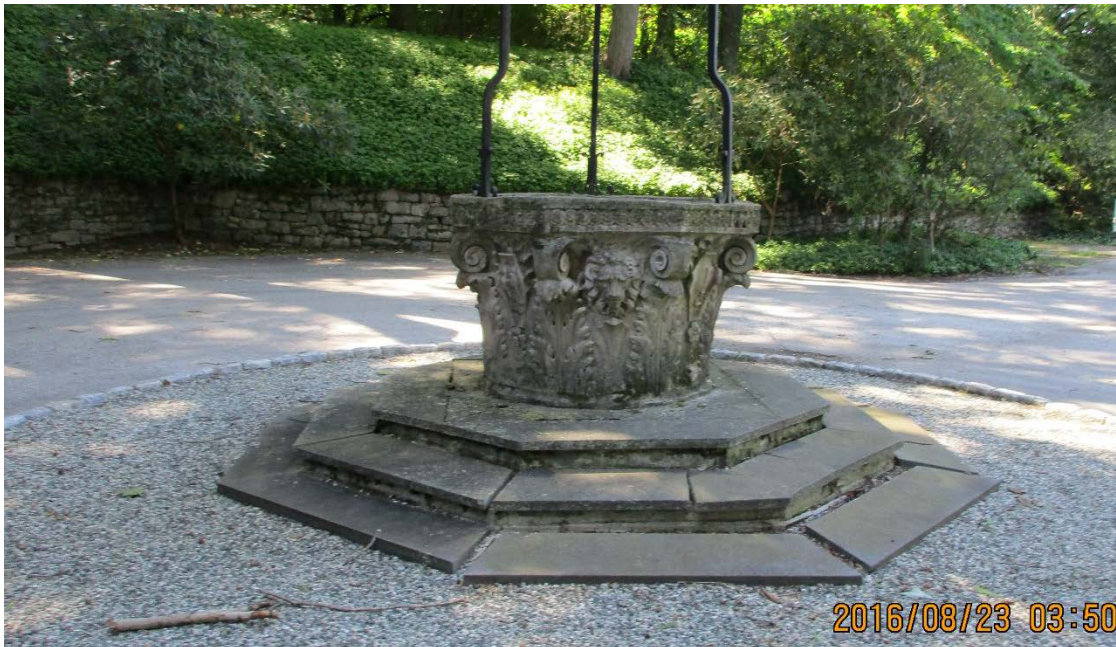
Paving, Curbing, Parking

The paved driveway leading to the house is in good condition. There are no curbs in this park setting. The courtyards are sloped toward drains. The paving has some cracking and some uneven areas due to tree roots heaving the pavement and freeze-thaw movement. The "well" feature in the secondary courtyard sits above the courtyard on a circular stone base raised by a series of steps. The pavers comprising the steps are mortared in-place and the mortar is cracked or missing in areas. Some of the steps are subsequently dislodged or uneven.
