Radnor Township
Stormwater Management Advisory Committee (SWMAC)
Agenda
7:00pm, Thursday, March 10, 2016

In accordance with the scope of work and cost proposal to provide engineering services for the evaluation of five (5) bridges/culverts submitted to Radnor Township on July 1, 2015, Gannett Fleming completed the field view and prepared a summary report for each bridge. The reports summarize the findings from field view and recommend the appropriate option to replace or rehabilitate the deteriorated structures. A conceptual construction cost estimate and estimate of engineering cost for the recommended work is prepared for each structure for your budgeting purposes. Actual engineering costs will be developed based on the final scope of services for each task.

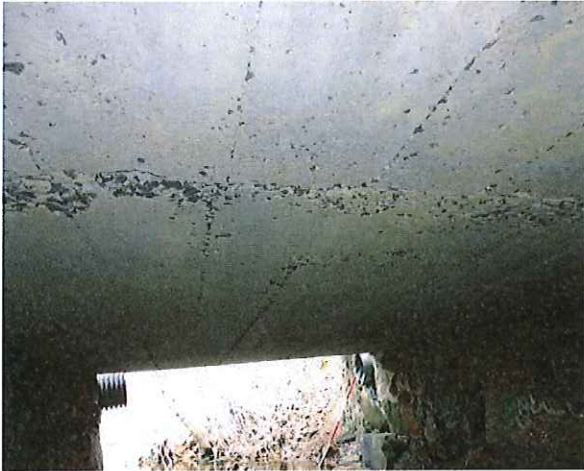
Under Deck View (H.C. in middle width)

The concrete slab superstructure of the main structure is in good condition with localized honeycombing and exposed aggregate. No spalls or exposed reinforcing steel is noted.

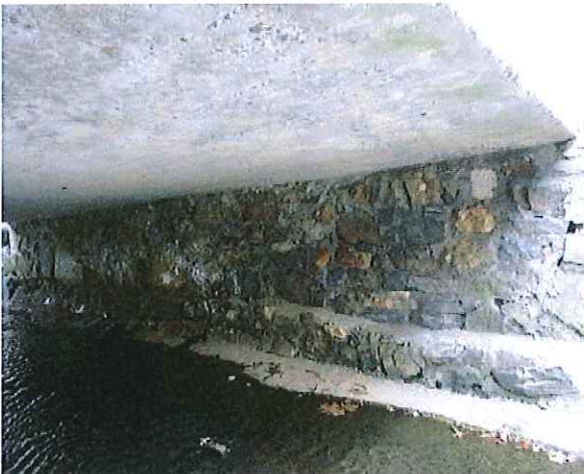
Typical Masonry Abutment

Both abutments and wingwalls are stone masonry, all are in good condition except for Wing A and Wing D.

- Replace superstructure and substructure of north pedestrian bridge.
- Repoint missing mortar joints in abutments and wingwalls.
- Repair/Repaint the south pedestrian bridge, update railing to meet the current standards.
- Fill the scour hole at outlet and in front of concrete apron of wingwalls B & C with riprap.
- We will discuss with the township about the need for updating safety features of roadway bridge and pedestrian bridges.
- Install the missing hazard marker at northwest corner.

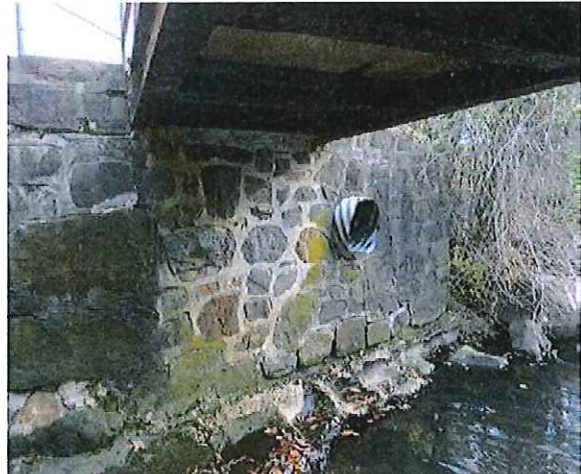
Wing B (Wing C similar)

Note that concrete aprons of varying width are present at both Wing B and Wing C (downstream wings). It is assumed that the aprons serve the purpose of splash block for ground water flows into the creek through drainage pipes. Both aprons are undermined up to 2'-0". Streambed under the bridge is paved with concrete and in good condition; water flow over the streambed is approximately 1" deep. A waterfall is formed at end of the paved streambed and a 2'-3" deep scour hole beyond the paved streambed between Wing B and Wing C is noticeable. There is no noticeable bank erosion.

Both downstream wingwalls (Wing B and Wing C) that support the south pedestrian bridge are in fair condition with a few missing mortar joints and undermining of concrete aprons. The Superstructure of the south pedestrian bridge is in fair condition with heavy rust in stringers and floor beams.

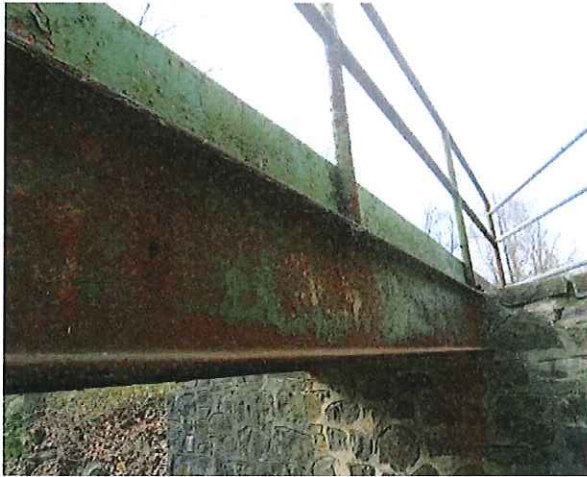
South Pedestrian Bridge Elevation View

The south pedestrian bridge features two (2) W12 stringers with five (5) W5 floor beams and a pressure-treated plywood stay-in-place form. Both stringers and floor beams exhibit heavy rust and delamination with minor section loss throughout; the plywood form is in fair condition.

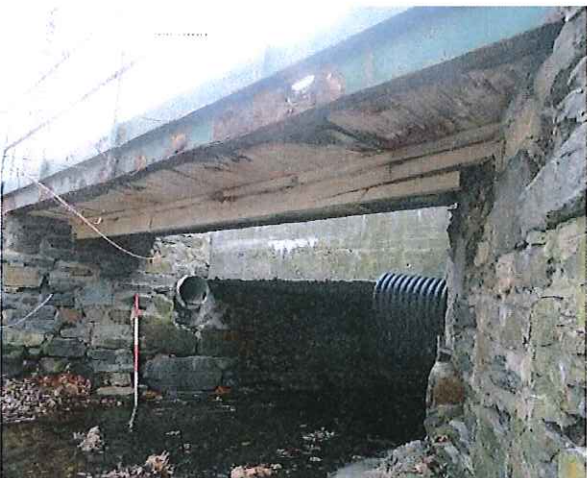
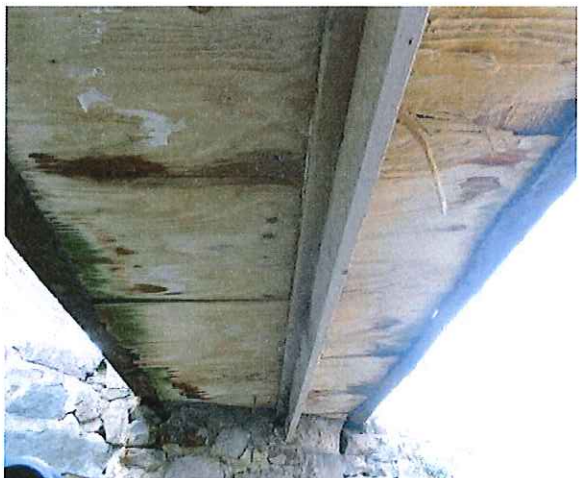
The north pedestrian bridge is composed of two (2) W8 stringers, concrete deck and plywood form, and is also supported by a built-up auxiliary timber T-beam (2x6 flange and stem). The W8 stringers are heavily rusted with 100% loss of webs and more than 50% loss of bottom flanges and are losing their carrying capacities. A Large hole is noticeable in the concrete deck and plywood form. The stem of the built-up timber T-beam splits at middle depth from the end notch.

The Superstructure of the north pedestrian bridge and Wing D are in poor condition. Wing A is in fair condition.

The existing bridge and south pedestrian bridge will be rehabilitated and therefore no Geotechnical Investigation is necessary. However, the replacement of the deteriorated superstructure of North Pedestrian Bridge and rebuild of Wings A & D that supports the pedestrian bridge is recommended.

Based on the field assessment and finding, it is recommended to replace the deteriorated superstructure and substructure of the north pedestrian bridge and rehabilitate the remaining structure. The major works are listed below:

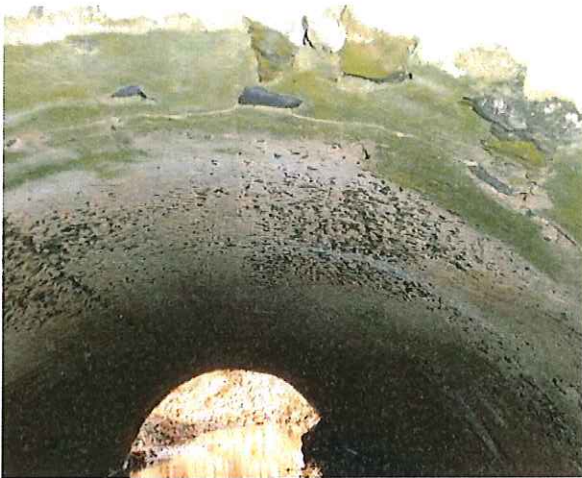
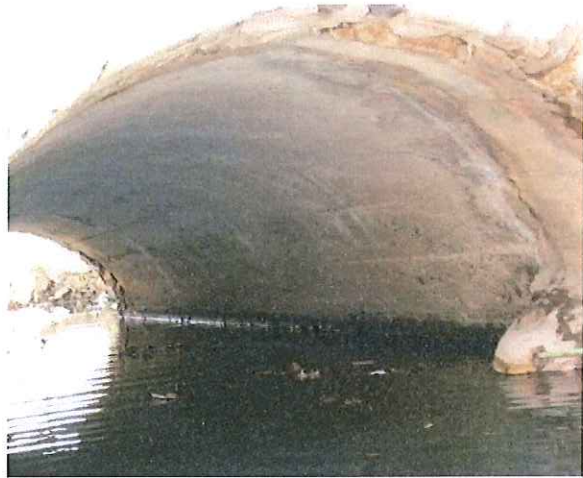
The concrete arch barrels are in fair condition with localized honeycombing and exposed aggregate. No signs of distress, spalls, cracks or exposed reinforcing steel are noted within the concrete arch barrels. Heavy scale is observed along the waterline in both concrete arch barrels. The end 2 feet of each arch barrel consist of the masonry spandrel walls (headwalls) and masonry barriers. There are large areas of missing stones and mortar present within the masonry spandrel walls.

The concrete portions of twin arch barrels are in fair condition. There is undermining up to 1'-0", along north barrel with a total length of 10'. Heavy scaling is noted along the water surface line and there is heavy debris accumulation in both barrels. There is a large scour hole at inlet of the culvert.

- Replace the existing masonry spandrel walls and barriers at both ends of the culvert to meet current PennDOT Standards.
- For consistency with roadway cross section with nearby newly constructed bridge, extend the existing arch barrels to accommodate a 5'-0" wide sidewalk.
- Provide formliner on headwalls and barriers to aesthetically blend with the newly constructed adjacent bridge.
- Remove and rebuild the downstream retaining wall.
- Underpin the footings and fill the scour hole at the inlet with riprap.
- Remove the tree at northeast corner.
- Install guide rail on non-sidewalk side if directed by the Township.
- Install Type M inlet and drainage.

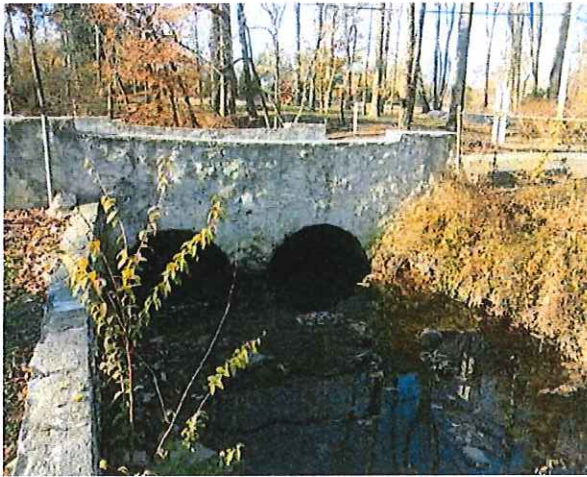
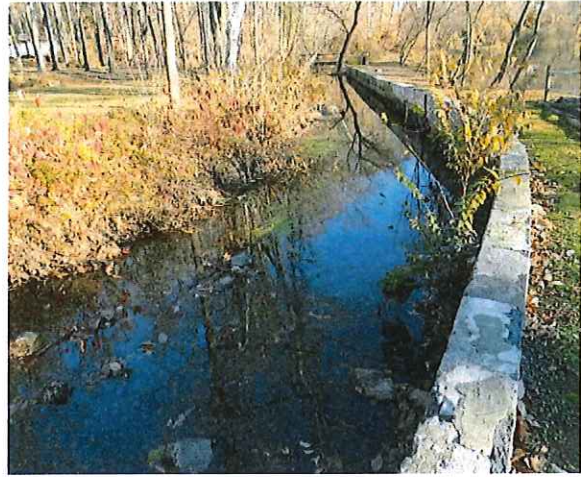
There is a stone masonry retaining wall that defines the edge of channel on the downstream south quadrant. The top width of retaining wall is 1'-0" wide and the height of retaining wall measured from streambed is approximately 4'-6" tall. The bottom 2'-6" of the wall has advanced deterioration with large area of undermining and missing stone and jointing along the length.

The masonry retaining wall along the downstream embankment is in serious condition with large areas of undermining and missing stone and jointing along the length.

The existing twin concrete arch barrel culvert will be rehabilitated and therefore no geotechnical investigation is necessary for the bridge. However, the retaining wall adjacent to the downstream side of the culvert is recommended to be replaced and will require geotechnical investigation. The geotechnical investigation will consist of drilling two borings to a maximum depth of 25 ft below the ground surface. Rock will be cored for 5 ft if encountered. Laboratory testing will be conducted on the recovered samples as necessary. Following the subsurface investigation and the laboratory testing GF will prepare a brief memo with recommendations.

Based on the field assessment and finding, it is recommended to rehabilitate the existing culvert and replace the entire downstream retaining wall. The major works are listed below:

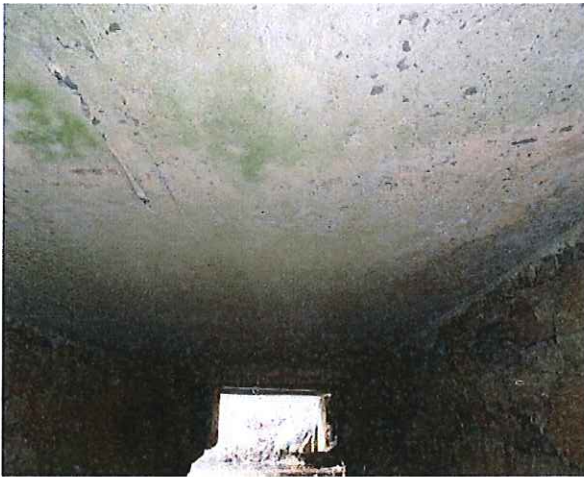
View of Original Concrete Slab Superstructure (underside)

The original slab bridge shows no spalls or sign of water leakage and in good condition. Both stone masonry abutments are generally in fair condition with voids and missing mortar joints occasionally at various locations along the base.

The original concrete slab superstructure is in good condition with no noticeable spalls, cracks or distress. The original stone masonry abutments are in fair condition with some undermining, missing stones and voids.

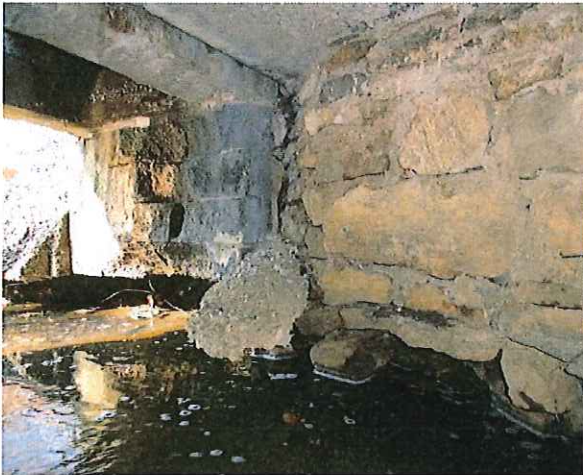
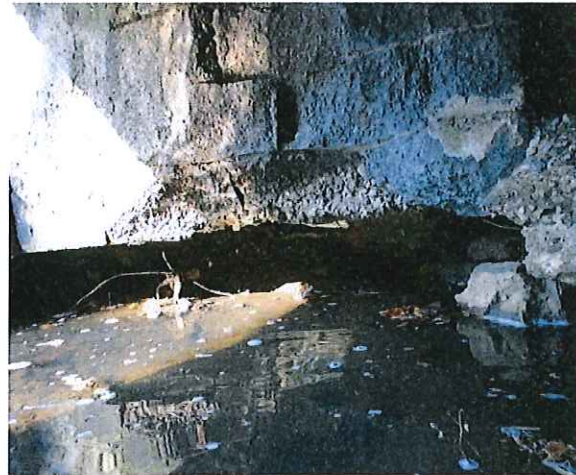
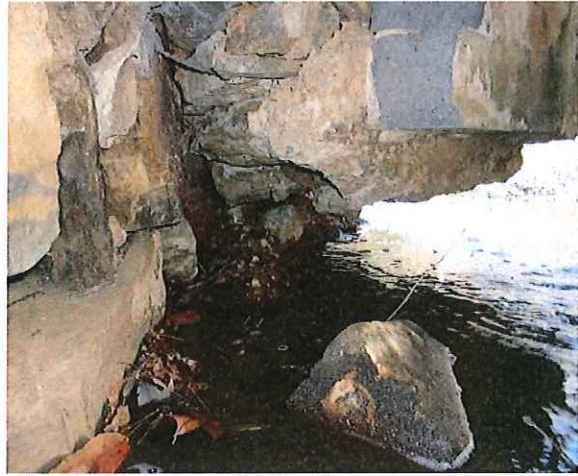
The widened inlet structure is in poor condition; both abutments are severely undermined.

The inlet structure is in poor condition, with both abutments undermined about 4 feet.

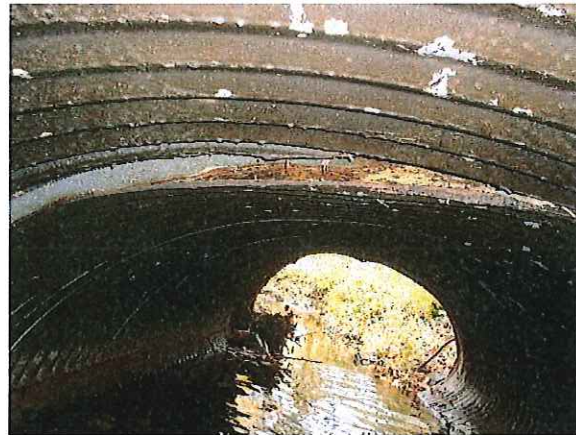
Upstream portion of East Pipe shows Excessive Deformation & Separation from Abutting Section

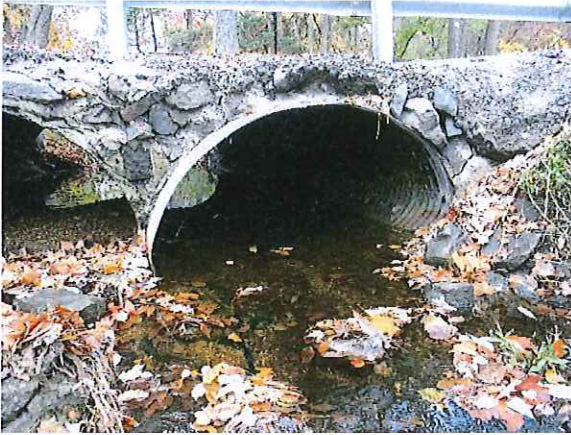
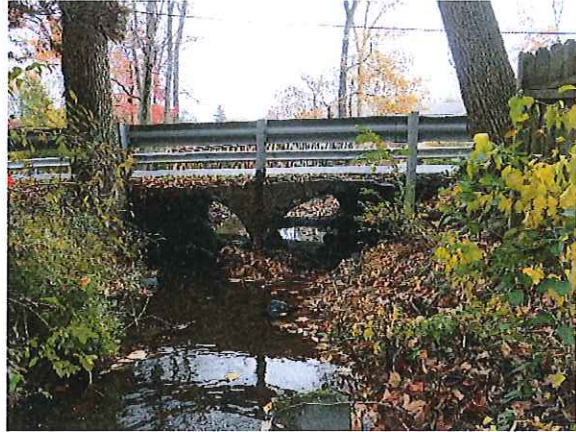
The south headwall is comprised of piled and grouted stones and has a few locations of missing grout joints and is in overall fair condition. The north headwall has areas of voids and loose stones above and between the corrugated pipes.

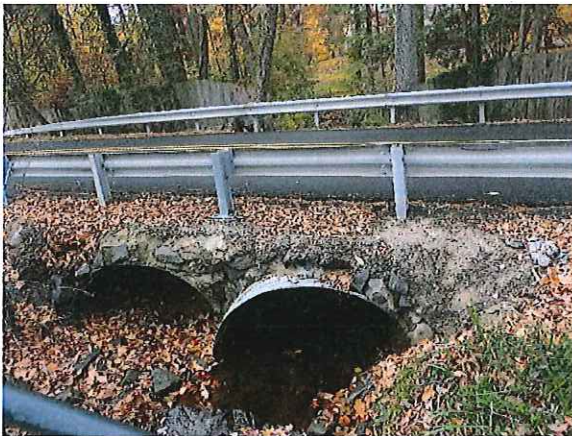
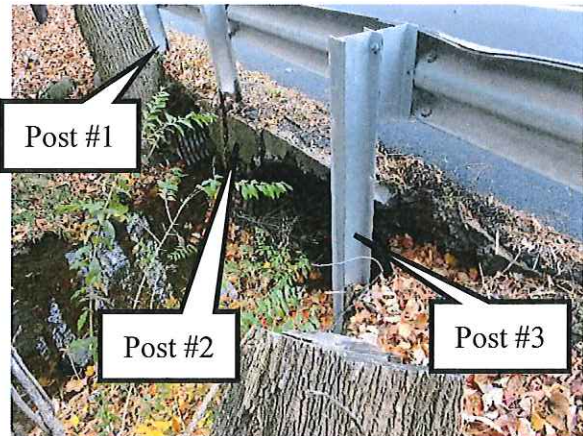
Guiderail extends across the culvert on both sides with railing posts engage each structure headwall. For the south headwall, the three posts are mounted to the headwall with baseplates and anchor bolts, these post and anchor bolt connections are in good condition, however the load carrying capacity of the headwall is questionable. For the north headwall, only the middle post (post #2) engages the headwall. There is severe section loss in posts #1 & #2. Post #1 is supported by a tree, post #2 is cast in the headwall and post #3 is supported from streambed, posts and guiderail are displaced.

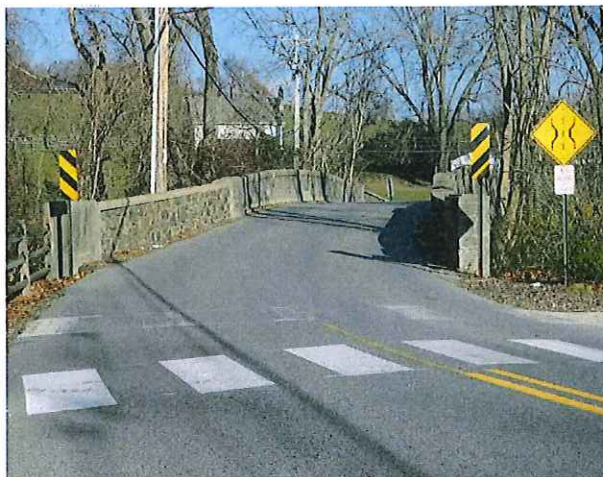
West Approach, Note Pedestrian Cross Walk was Previously Relocated Once

The lane widths of this roadway are substandard across the structure. Lane widths of 9' to 9'-4" are provided whereas the minimum allowable is 10' plus 1' offset to the bridge barrier for a total

- Repair spalls/cracks in fascia of arch ring.
- Remove trees and provide riprap protection at downstream left bank to prevent further bank erosion.
- Relocate the pedestrian crosswalk to the west, away from the structure, to the intersection with Earles Lane. The trails within the parks could be reconfigured with minimal earth disturbance to affect this change. This will allow vehicles to better observe pedestrians in the crosswalk and will allow pedestrians to see oncoming traffic from the bridge.
- Provide painted yield bars on the roadway at both bridge approaches with adjacent signing "YIELD TO ONCOMING TRAFFIC". This will allow vehicles on either approach to yield to a vehicle already on the structure.
- Provide guide rail or crash worthy end treatments on all four corners of the structure.

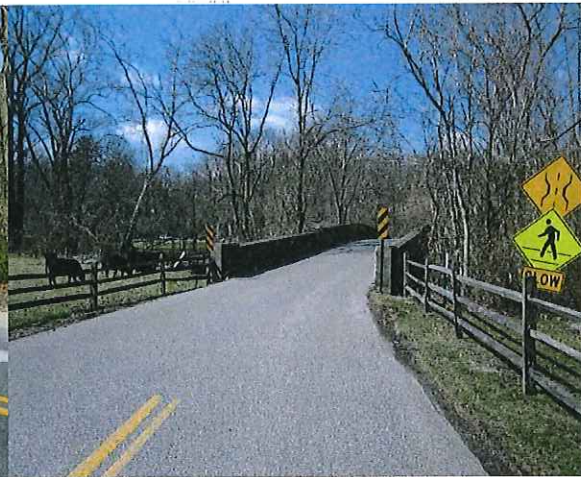
East Approach, Note Sign of Pedestrian Crossing

Positive protection for the blunt ends of the bridge barrier is not provided. Only hazard markers denote the location on each of the four approaches.
