Radnor Township Problem Locations Map

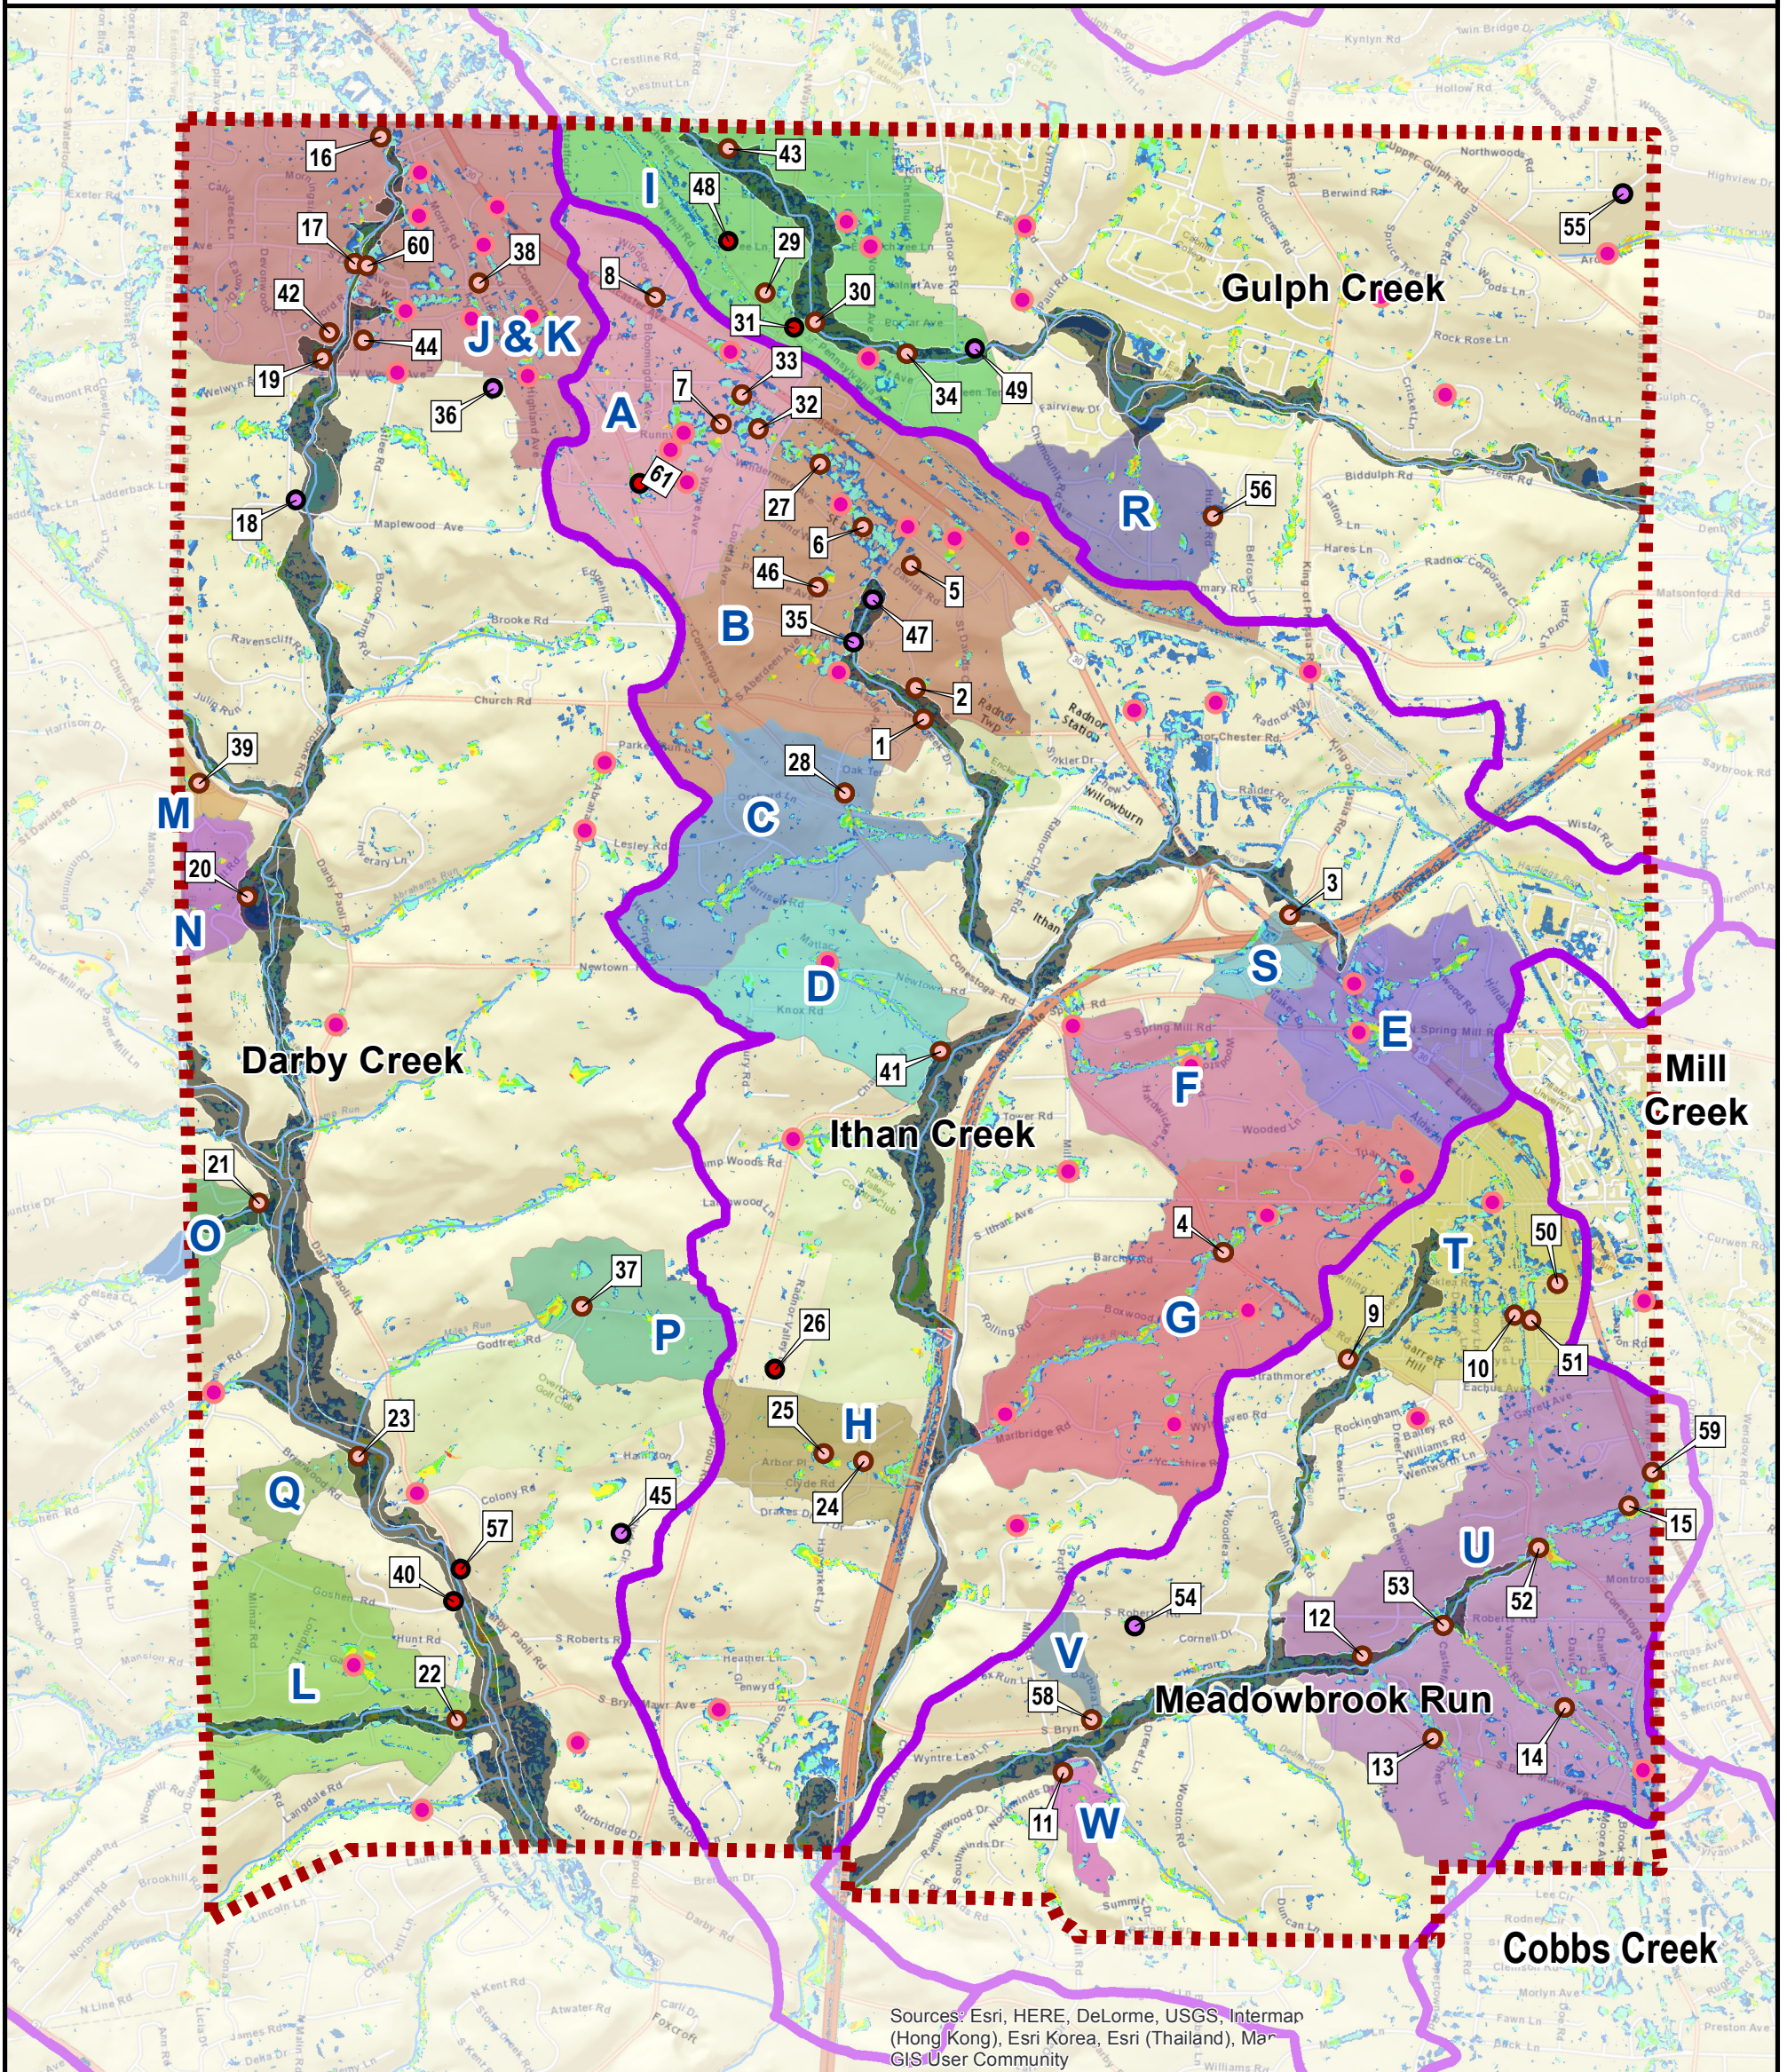
NOTE: Flood Depth Results modeled by CH2M HILL using Flood Modeller Suite.
